THE DEMESA-SANCHEZ HOUSE

43 St. George St. Augustine, Florida

HISTORIC STRUCTURE REPORT

Historic Preservation Program, DCP, University of Florida

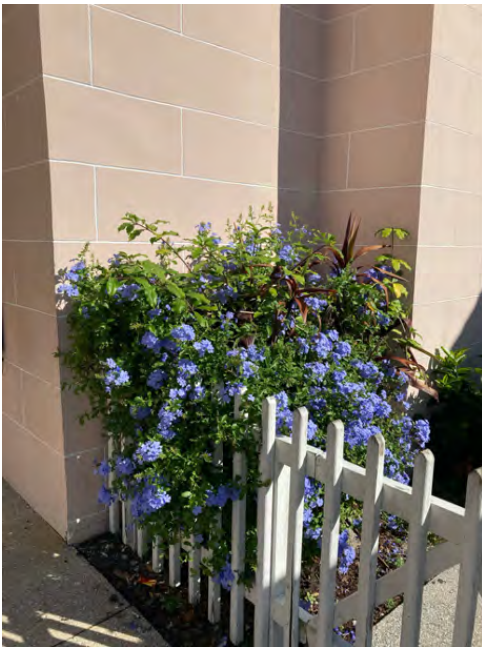
A: West Wing, S facade, looking NE

Some paving and site features impede site water flow away from the building. The westernmost concrete walkway that leads to the south façade should be either removed or replaced to promote drainage of water away from the building.

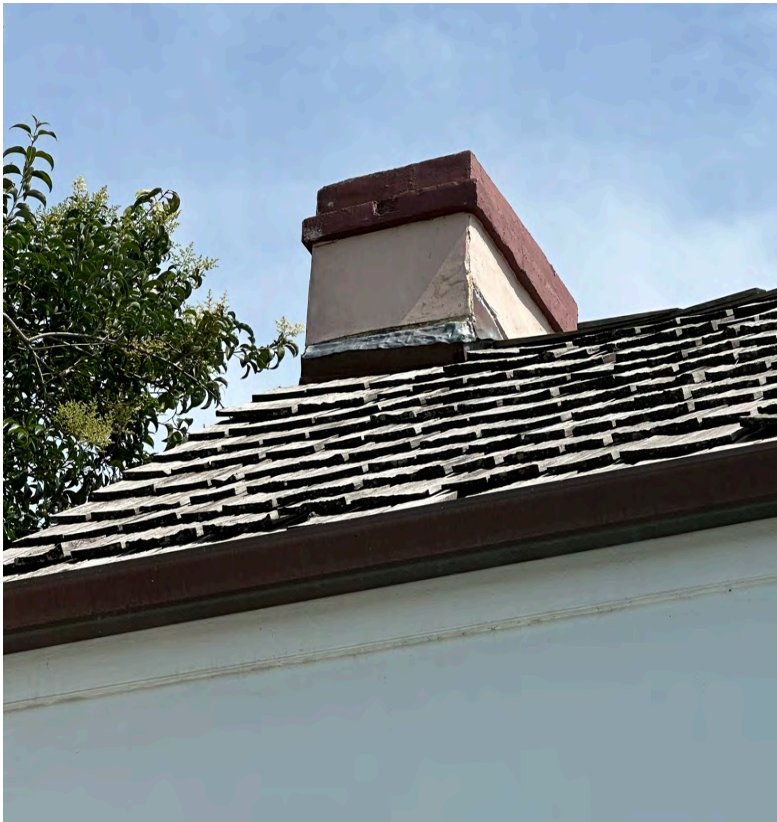
B: East Wing, roof's N slope, looking SE and up

Overall, the flashing materials appear to be in good condition at the chimney/roof penetrations at the east chimney and the south chimney. The drip edges appear secure and in good condition. The gutters and downspouts appear to be well-fastened and in good condition (C).

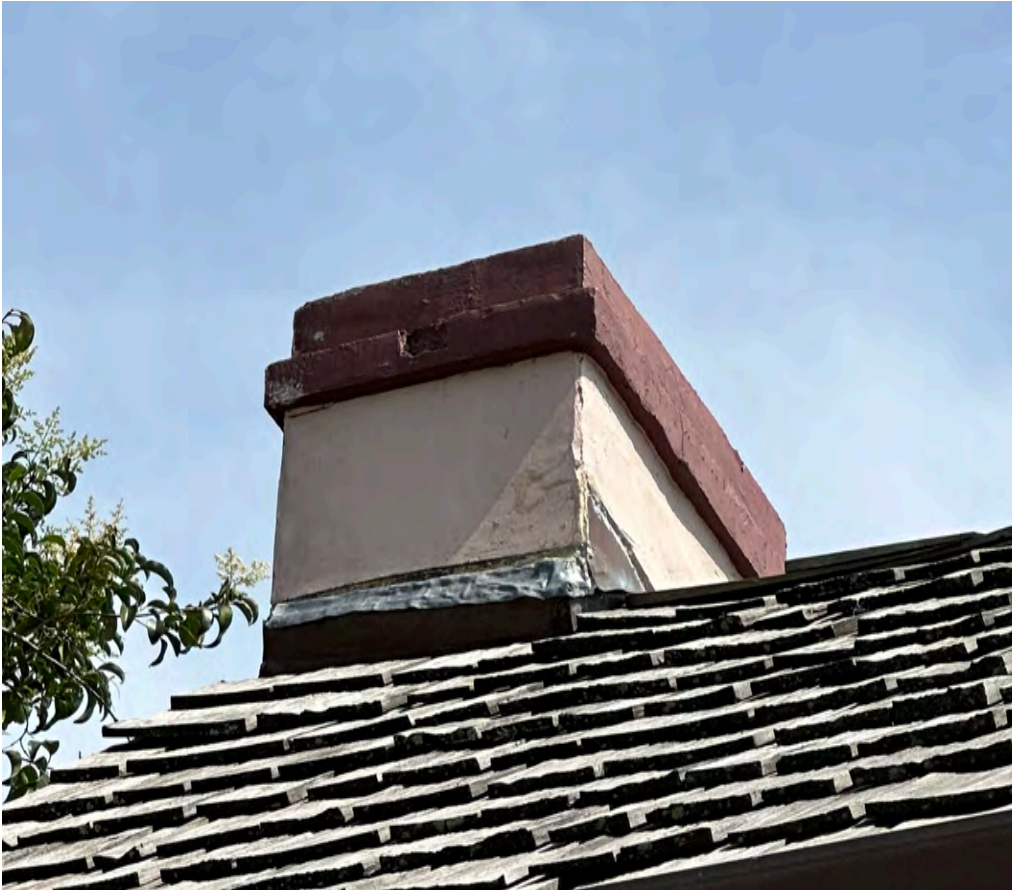
D: East Wing, E wall chimney, looking SE and up

The east wall chimney's painted stucco, masonry and cap appear to be in good condition on the exterior

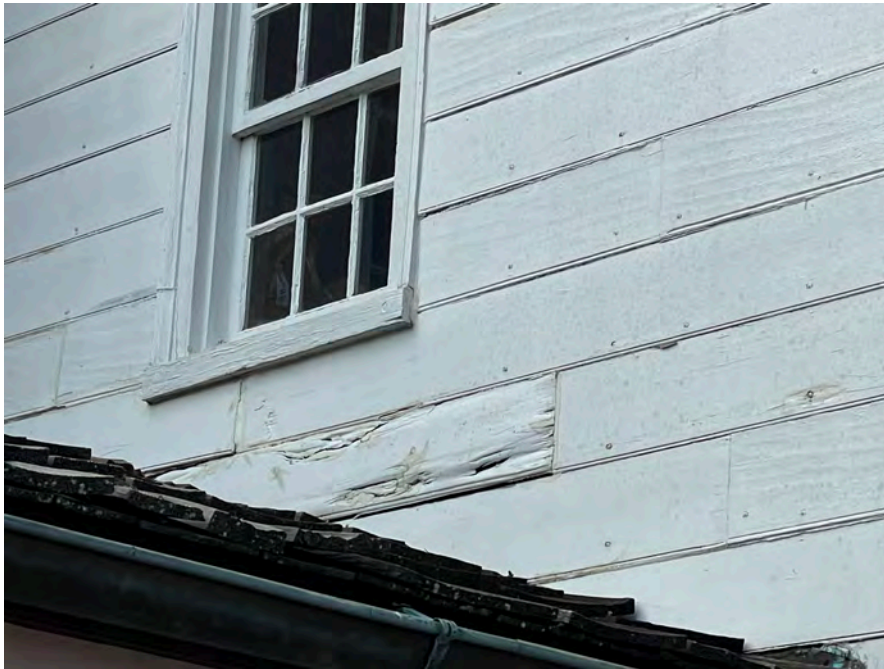
E: East Wing, S facade, looking NE, November 2022

Repairs to this material were observed during the Fall 2022 site visits. The condition of this material now appears to be good.

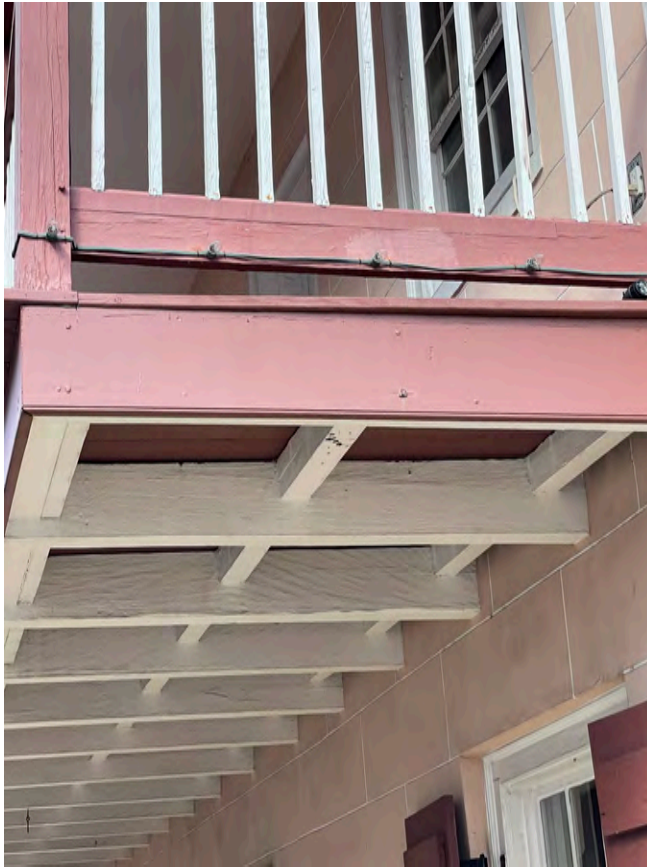
D: West Wing, Balcony, looking NE and up

Most of the wood elements of the balcony are in good condition (A, B, C, D). The woodwork applied to the façade at the upper south-west corner displays some minor damage and chipped paint (E).

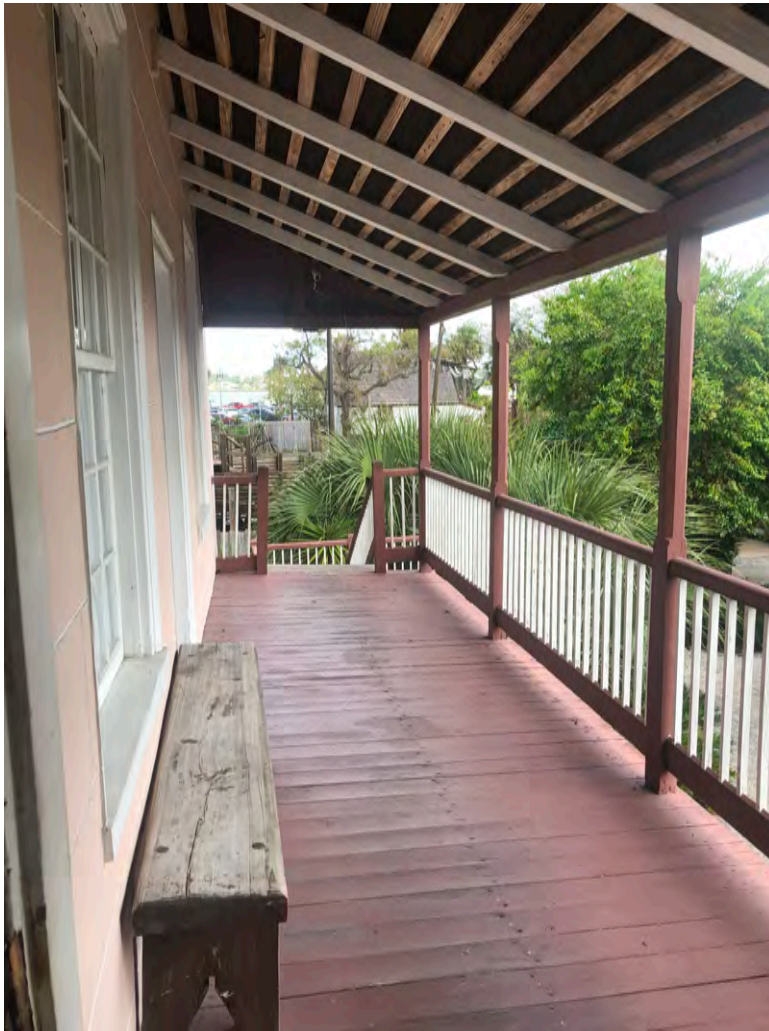
A: East Wing, loggia, looking E

Most of the wood elements of the loggia are in good condition (A, B).

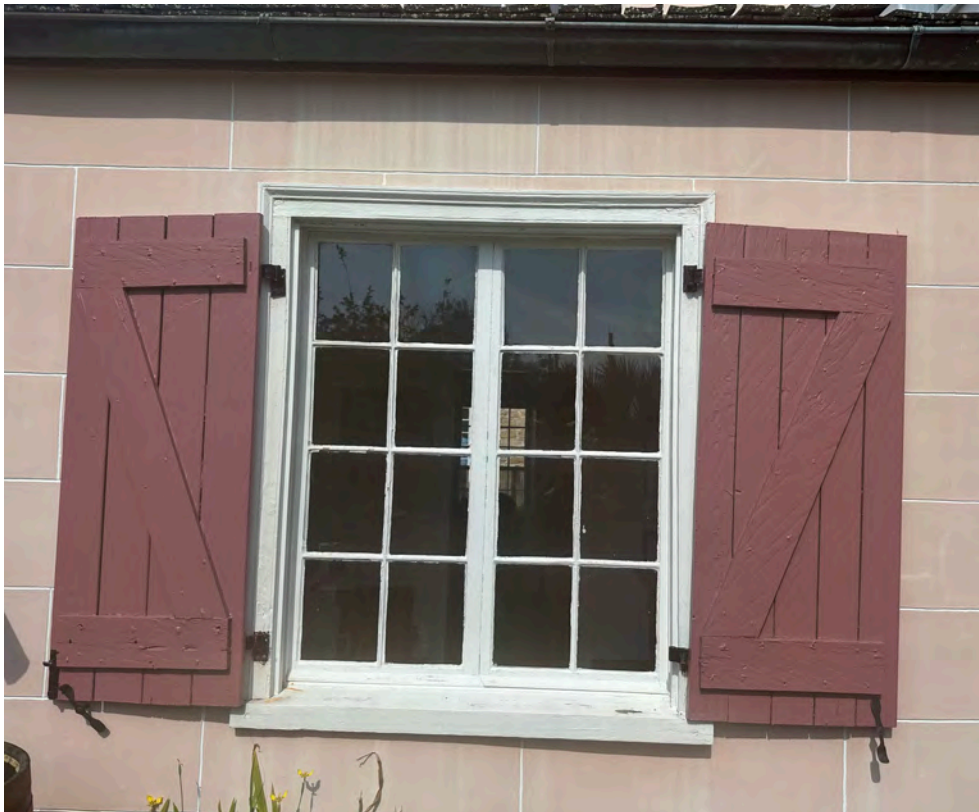
A: West Wing, E facade, window 1E2, looking W

Shutter at window 1E2 is in good condition (A).

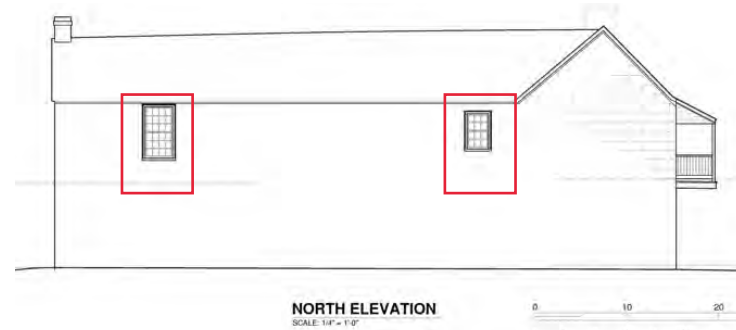
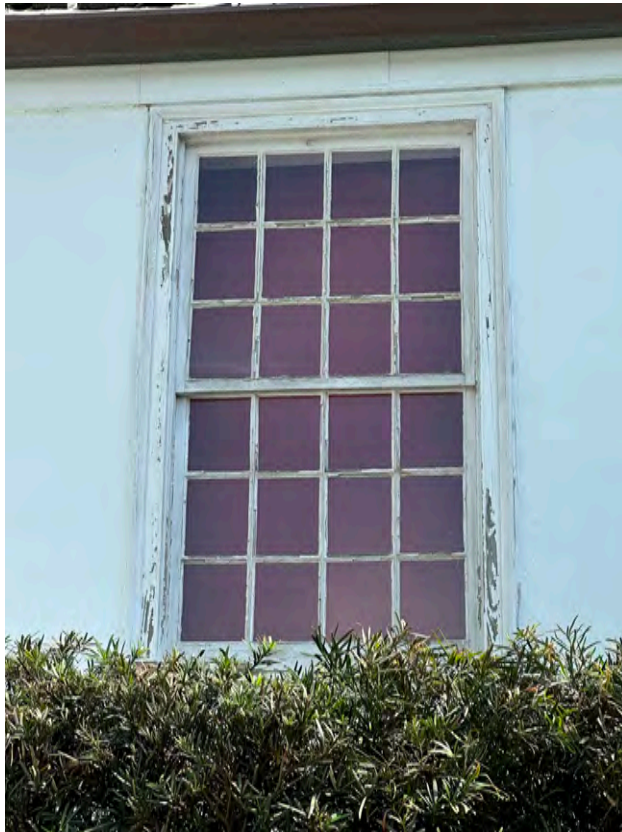
A: East Wing, N facade, looking S Window 2N2

Window 2N2 appears in fair condition, with significant amount of peeling paint on the frames and sash, the sill appears to have some rot (A). Shrubs obscure most of the sill board from view.

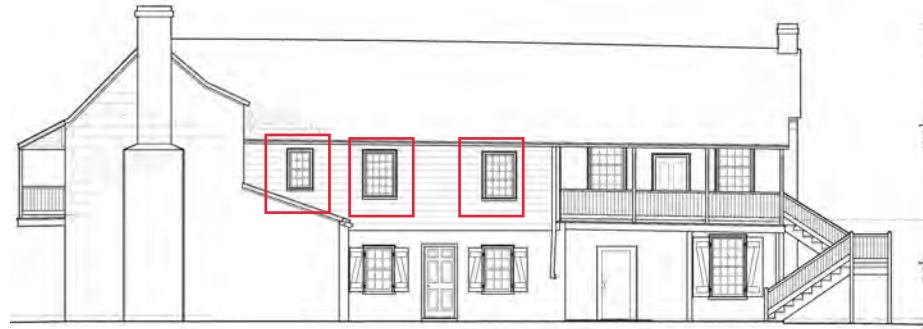
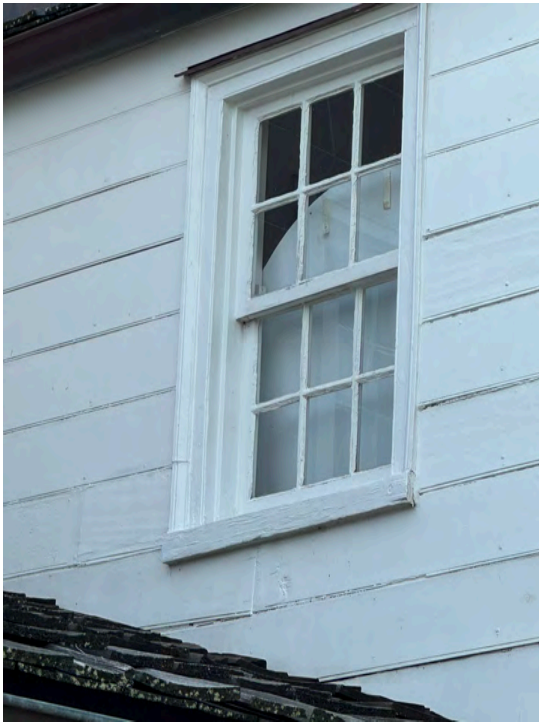
A: East Wing, window 2S5, looking NE and up

Window 2S4 is in overall good condition, there is cracking and splitting of the wood of the projecting sill piece (B).

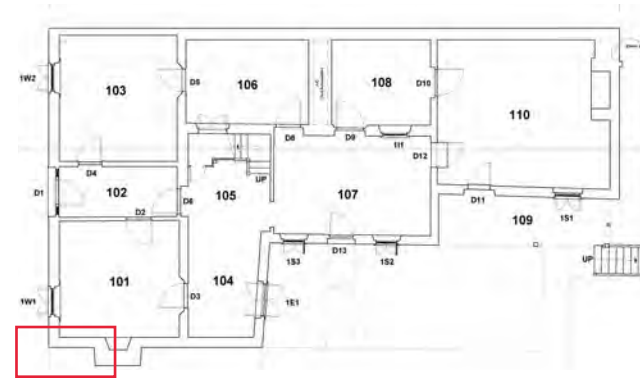
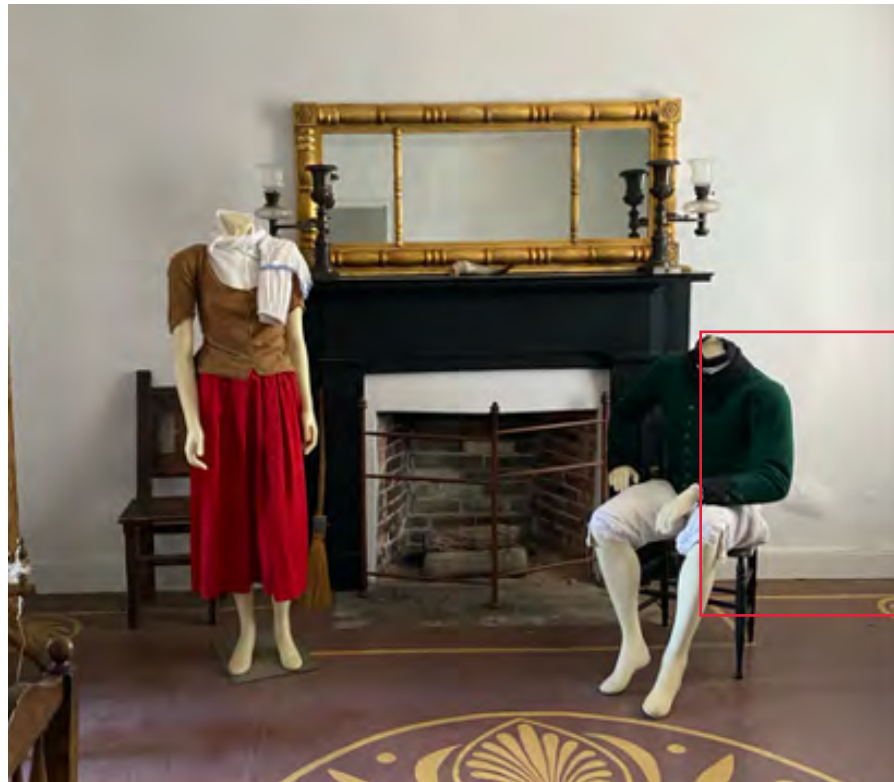
A: Room 101, looking S

There is a small area of bubbling painted plaster on the south wall to the west of the fireplace (B).

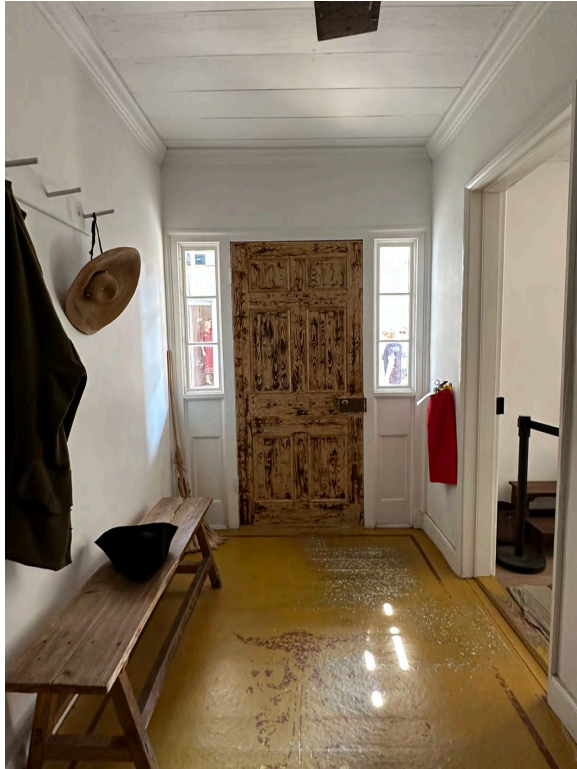
A: Room 102, looking W

Painted ornament on the wood floor is fading away (B).

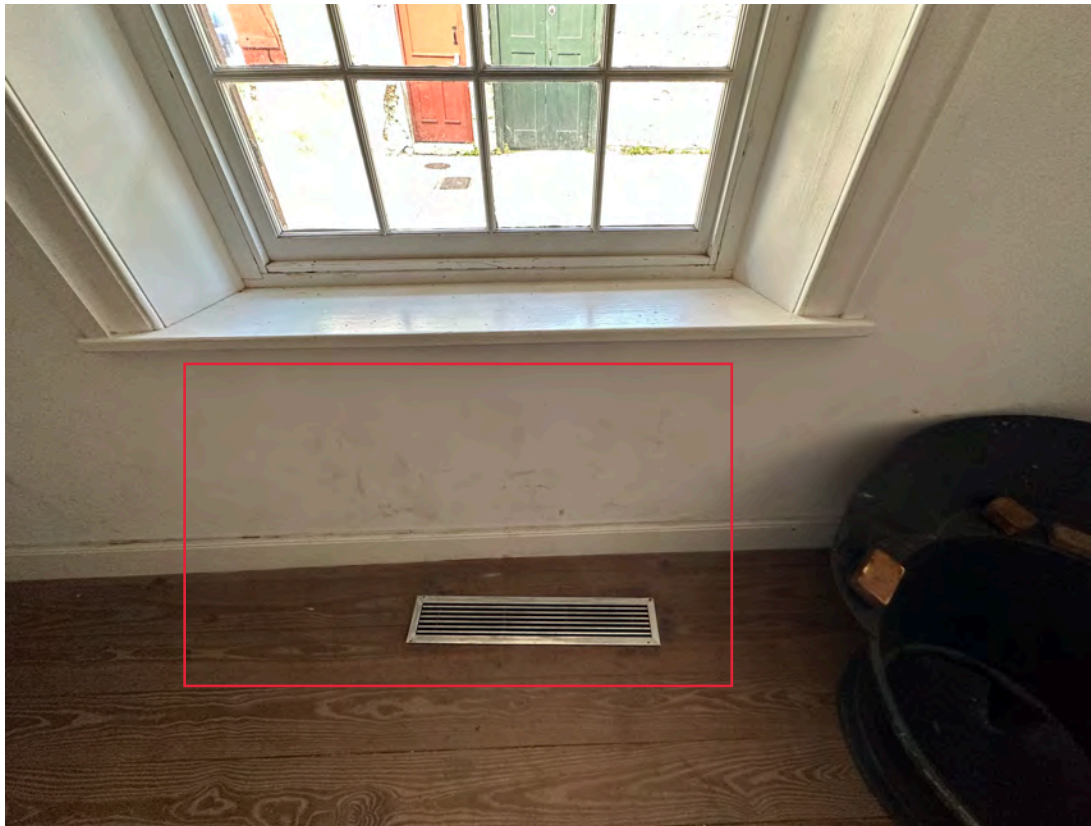
A: Room 103, looking W

Minor plaster damage on lower area of wall near and below sill area of window 1W2, vertical plaster crack on east wall.

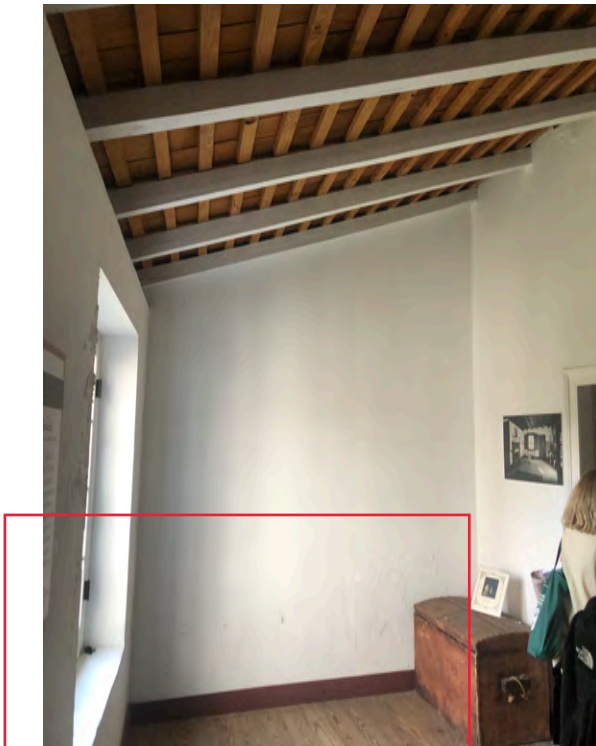
B: Rooms 104 and 105, looking S

- west wall, high on the wall under the exposed beams (A)
- west wall, low on wall next to the wood staircase (A)
- south wall, low on wall below sill height (B)
- east wall, around the window opening (1E1), more extensive plaster damage along the wall below the window sill height (C)

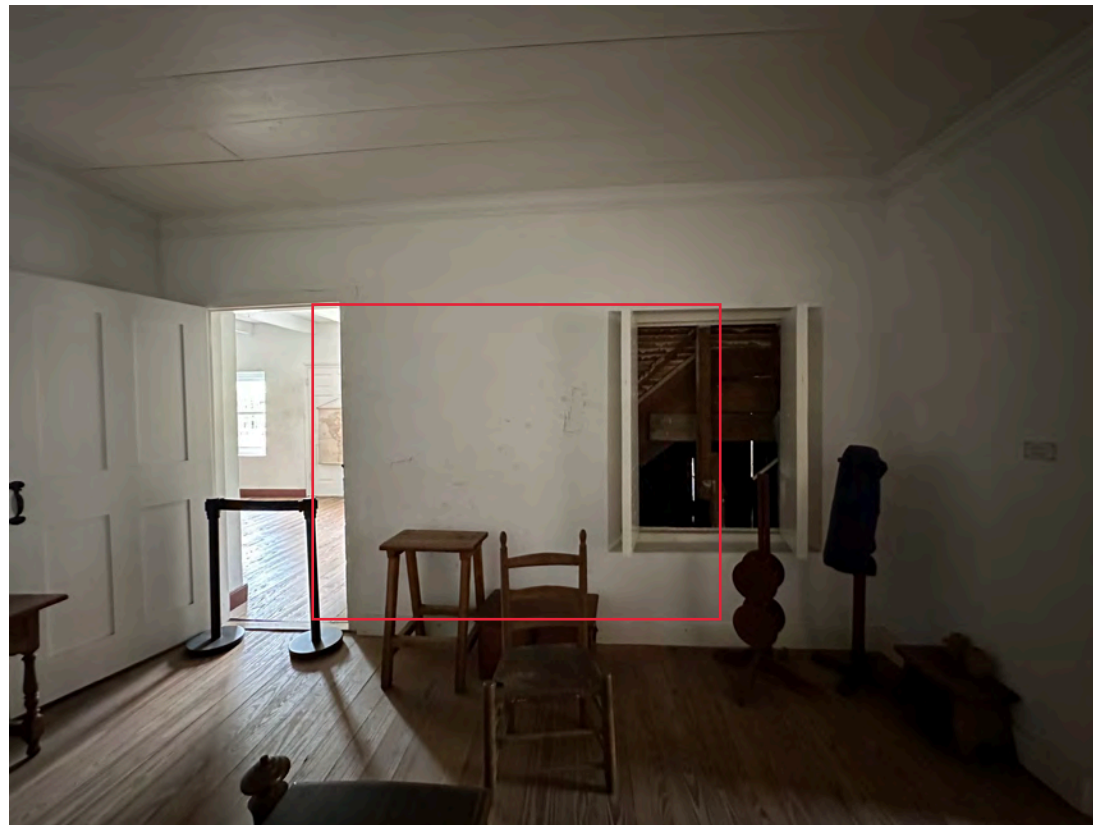
A: Room 106, looking NE

Some evidence of plaster damage on the south wall (A).

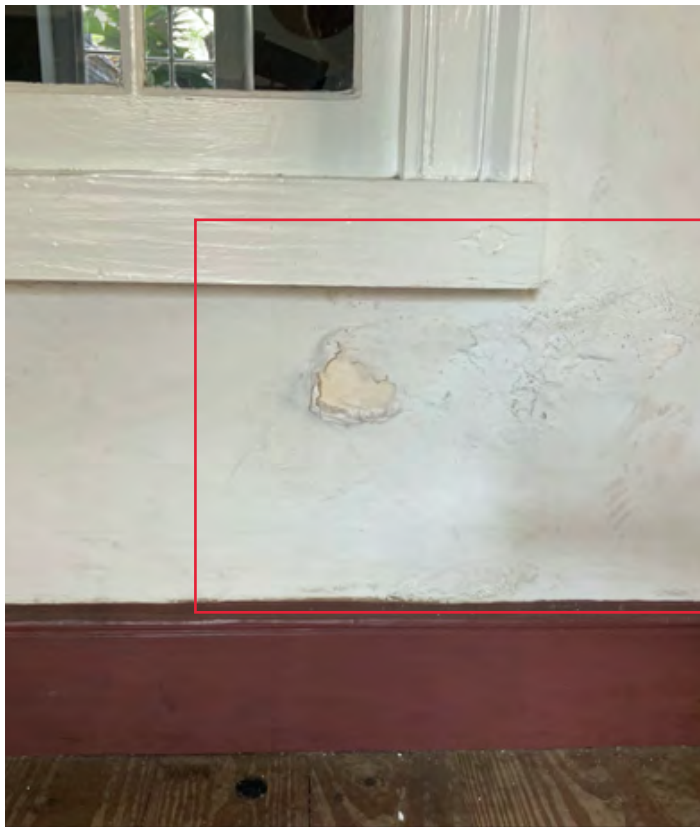
A: Room 107, looking N

Plaster damage on north wall and low on the south wall (A, B).

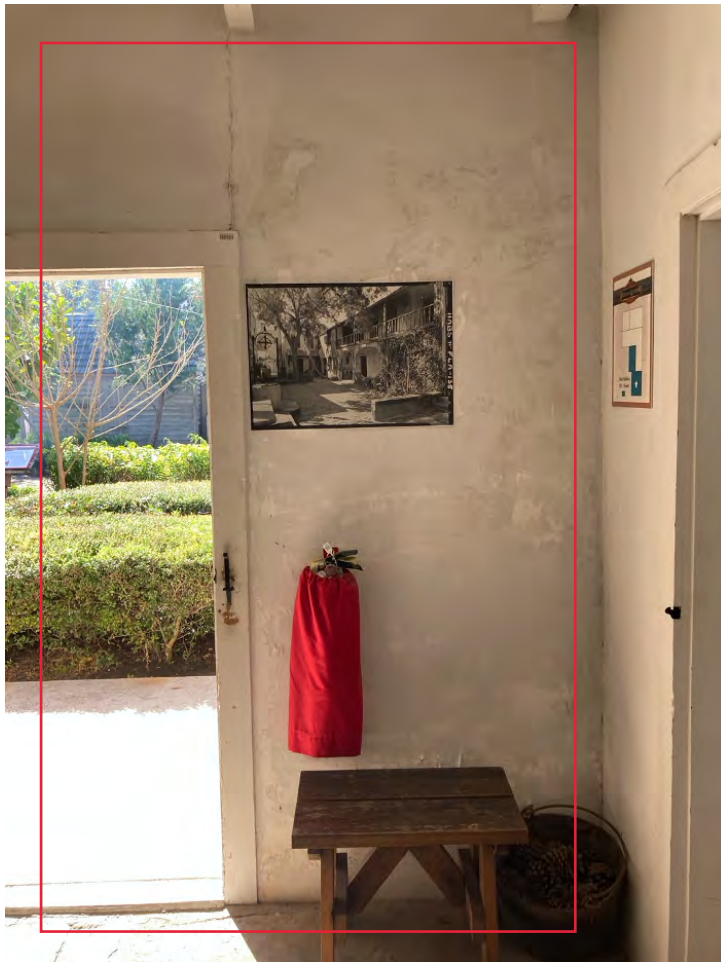
A: Room 110 , looking S

Plaster damage at south and east walls (A, B).

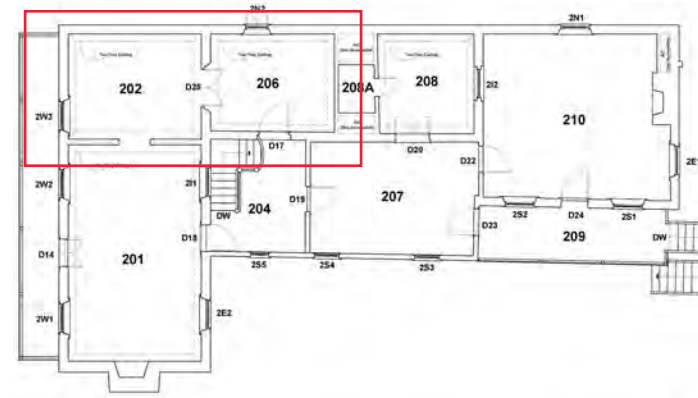
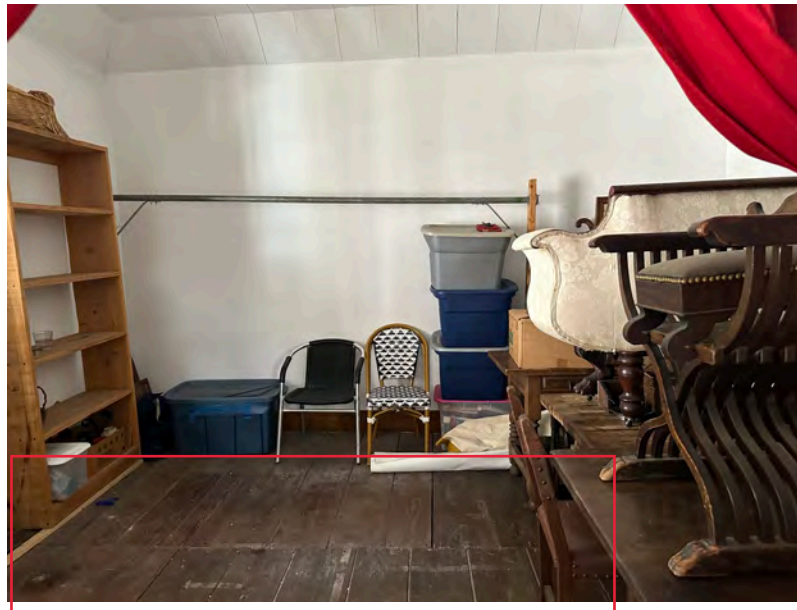
A: Room 202, looking N

Limited visibility, plaster damage on the north (exterior wall), and around the window 2N1 sill area (B).

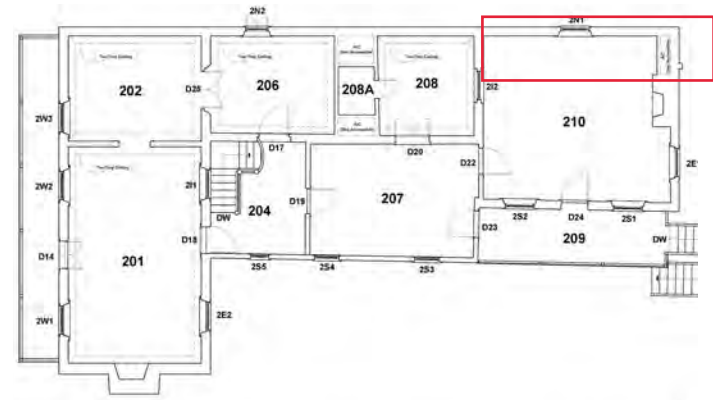
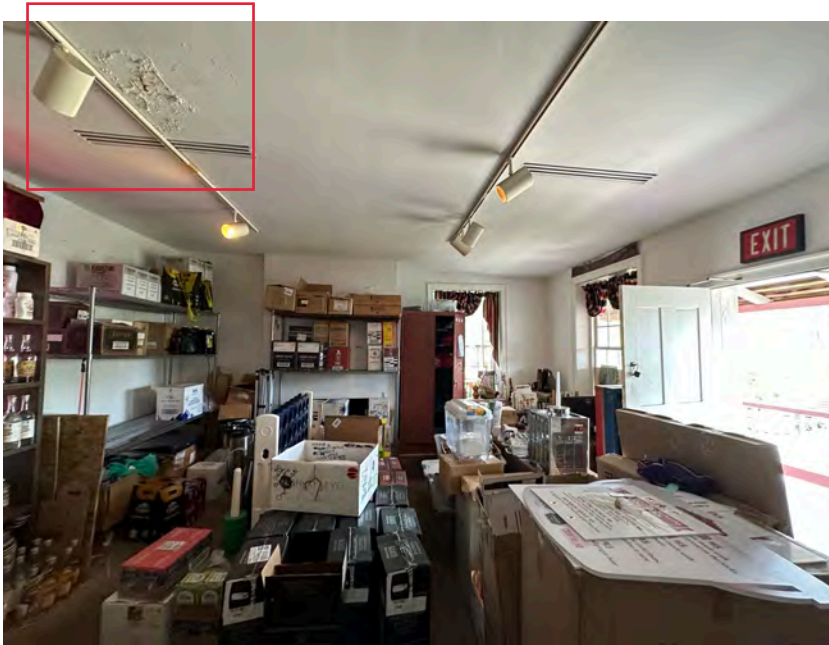
A: Room 210, looking E

Limited visibility due to contents of space, plaster damage at ceiling near north wall (A, C) and near the window 2N1 (B).
