# Paredes-Dodge House

HISTORIC STRUCTURE REPORT  
2017-2019

ST. AUGUSTINE, FL

Field Investigation: 2017-2019  
Publication of Report: Spring 2021

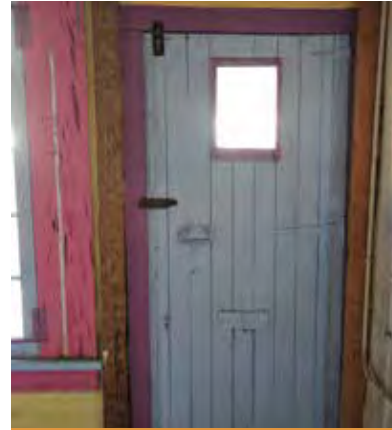
FW-07

Nails and racks for displaying merchandise did minor damage to the wood reinforcement framing, window casing, and door, though they are in good condition.

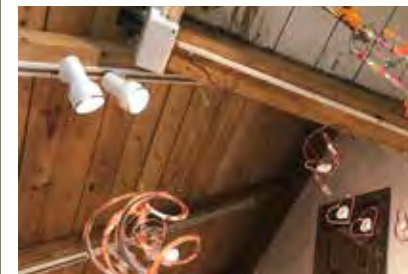
FC-03

The roof ceiling of the west extension (Room 103 and 104) was redone recently and is in good condition.

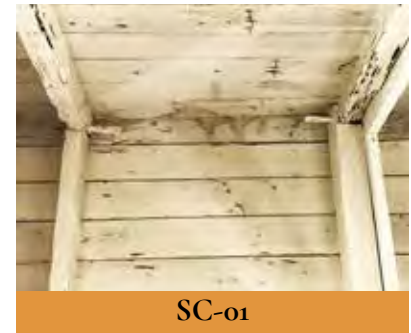
### Room 201.

Water stains are visible throughout the roof decking, rafters, and ridge. At the roof ridge, the historic rafters are damaged due to water intrusion.

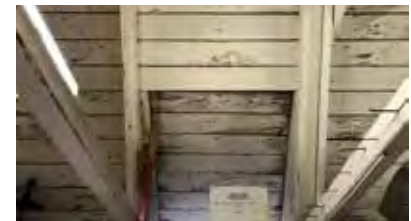
### Room 201, East.

Water stains exist along the edge of the eastern shed dormers' ceilings. Some of the deck panels were replaced as part of the roof repair in 2018.

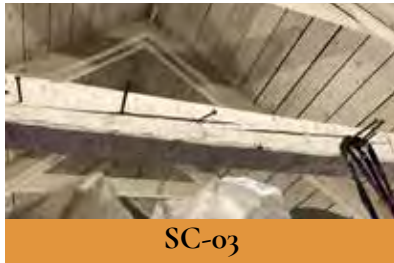
SC-03

**Room 201.**  
Small cracks exist on some of the historic framing elements. On this particular rafter tie, nails have caused or worsened the splits.

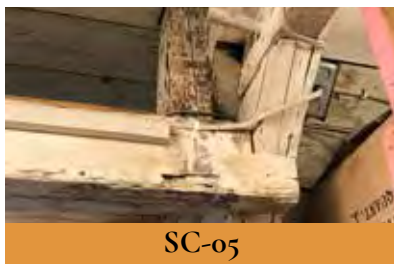
SC-05

**Room 201.**  
Minor water damage, including paint peeling, staining, and slight decay, are visible at the joint of the rafter, rafter tie, roof decking, and dormer joist. One of the decking panels was replaced in 2018.

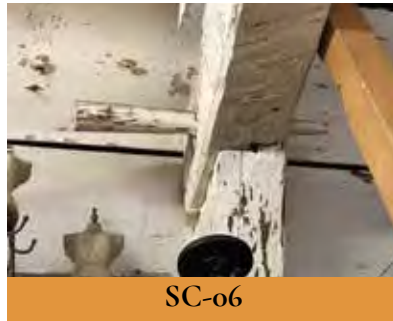
SC-06

**Room 201.**  
Historic wood pegs are intact and hold the rafters and rafter ties together.

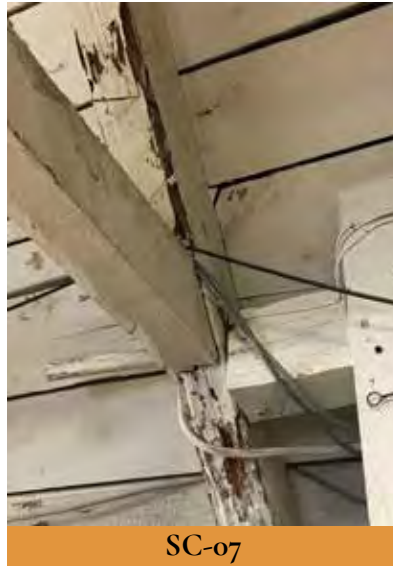
SC-07

**Room 201.**  
Wood rot exists on this rafter's western lower portion.

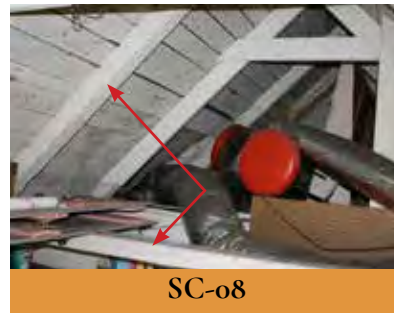
SC-08

**Room 201.**  
This wood truss appears to be an earlier replacement, possibly made before the five modern-looking reinforcement framings.

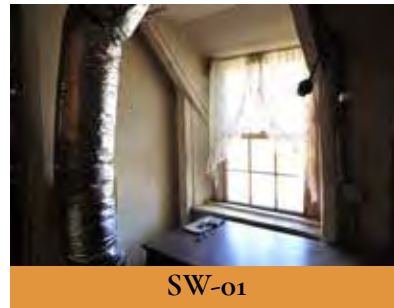
SW-01

**Room 201 and 202, East.**  
The eastern dormer windows are overall in fair condition. The lower sash in Room 202 and some parts of the window frames were replaced before 2017.

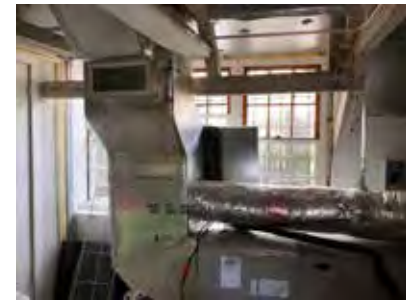
SW-02

**Room 201 and 203, West.**  
Large air conditioning units occupy the inside and outside (balcony) of the west dormer. The quadruple window is in fair condition. Two of the upper hung sashes were replaced recently (before 2017).

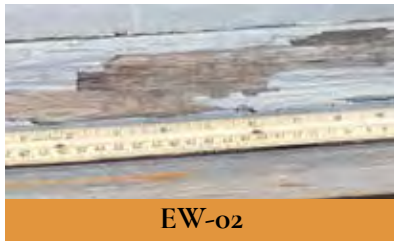
EW-02

Cracks are present where the side jamb, sill, sub sill, and wall meet. The lower jamb has wood rot from moisture.

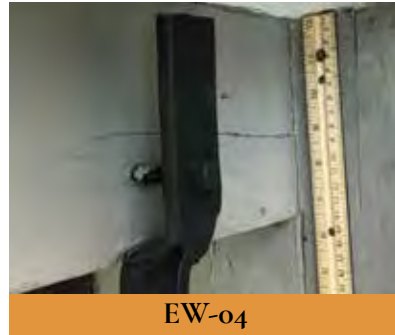
EW-04

The bolts holding the window grilles are coming loose and backing out of the wood frames of both the windows.

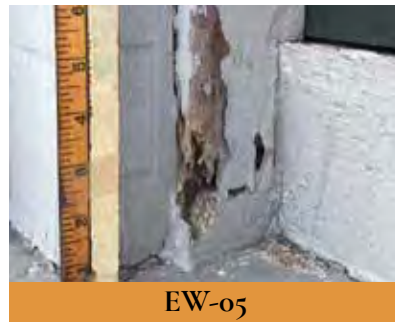
EW-05

Wood rot from moisture at the bottom of the door frame on both sides.

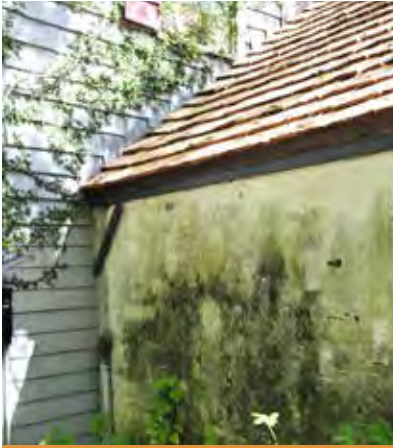
WW-01

The stucco-finished coquina wall has mechanical damage from nailing merchandise. The west wall in the shadow provides an environment for algae to grow.

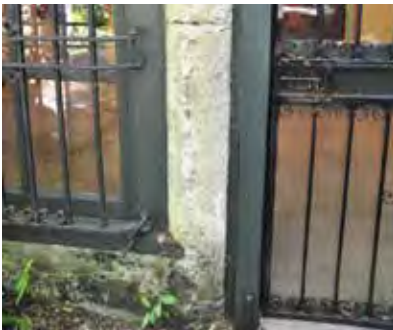
WW-02

Two cylindrical columns of the rear entrance expose its unfinished coquina. Both have partial patches with coquina concrete, lime, and cement mortar. This appears to be repair work from different periods to address the disintegration of the coquina.

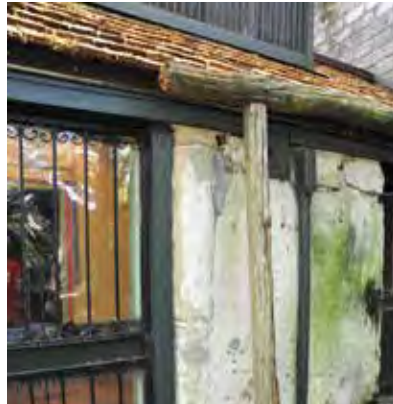
WW-03

Between the rear entrance and southwest window, the wall has a deep crack along the block course on top. If it is not a crack, the top blocks might have been intentionally extracted for an intervention in the past. Currently, the blocks are poorly repointed with portland cement and small coquina rubble.

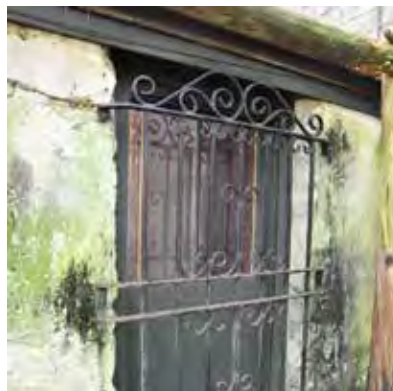
WW-04

The iron grilles show slight corrosion.

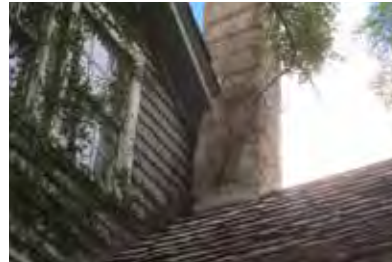
WR-02

Minor soiling and black algae are present at the west side of the coquina-block chimney that remains in shadow. A mortar patch is where the chimney and roof ridge meet. It appears to be a past repair for the fragmentation of the coquina. A newer chimney cap covers the older rusting one.

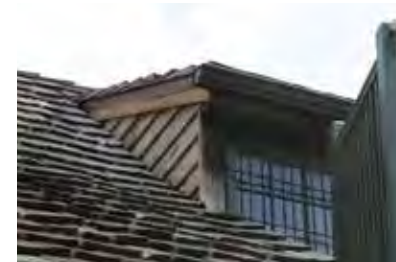
WR-03

Decay, like water-driven rotting, is present on the side clapboards of the dormer, especially where the siding meets the roof slope. A dark stain is on the window trim.

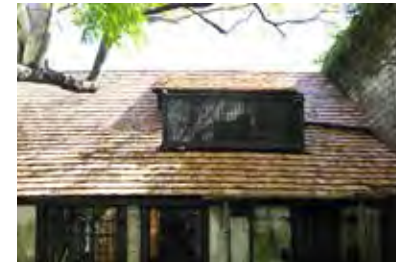
WR-04

In 2018, the wood shakes were replaced, and biological growth at the roof was removed.

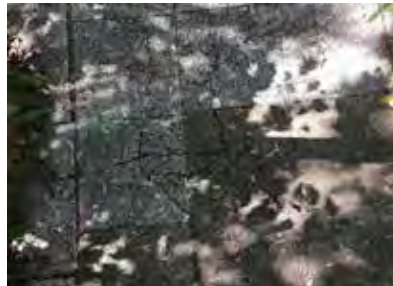
**LP-04**

The concrete pavement is between the brick pavements to the north. All of the concrete tiles have varying degrees of cracks. The tiles have two different color tones.

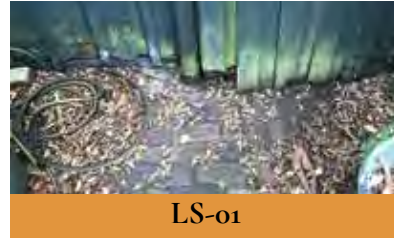
**LS-01**

The board-and-batten structure, which used to be a restroom, is located at the southwest corner of the building. Splash-up water damage (wood rot) and green algae had been present at the bottom wall. In 2019, the structure was repaired.

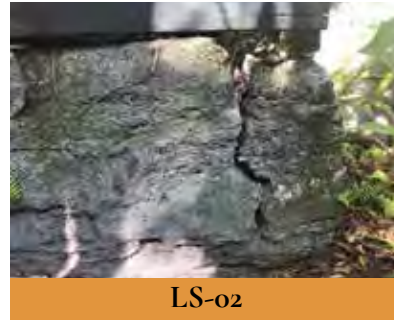
**LS-02**

The historic well (built in 1948 or before) is located at the northwest corner of the building. A significant crack and algae occur on the coquina structure.

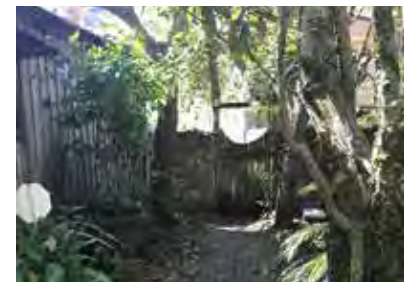
**LS-05**

Soiling and wet stain exist at the bottom of the wood gate.
