THE DEMESA-SANCHEZ HOUSE

43 St. George St. Augustine, Florida

HISTORIC STRUCTURE REPORT

Historic Preservation Program, DCP, University of Florida

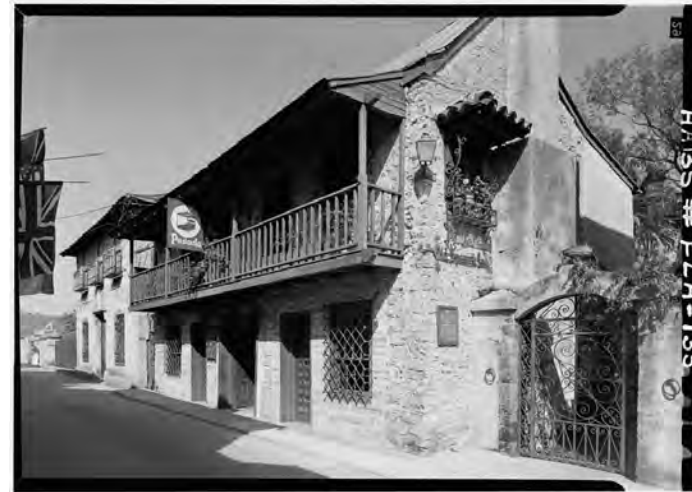
Figure 9 Image Source: Historic American Buildings Survey. De Mesa-Sanchez House, 43 Saint George Street, Saint Augustine, St. Johns County, FL. Library of Congress Prints and Photographs Division Washington, D.C. Accessed July 25, 2021. <http://www.loc.gov/resource/hhh.fl0203.photos/?sp=4>.

In 1959 Gerald Horton Bath remodeled the building to appear as a Spanish Inn that might have appeared during the Spanish period of the town (fig. 9).⁴⁶ Several windows and doors were replaced during the remodeling, but most eighteenth- and nineteenth-century fabric was left intact. The balcony was reconstructed along the length of the west facade. However, because vehicular traffic was still allowed on St. Augustine streets, it was only half as wide as it had originally been. The 1960s images show the sidewalk along the St. George Street balcony, which is narrower than the existing one. A shed roof extended over the balcony and above the street.⁴⁷

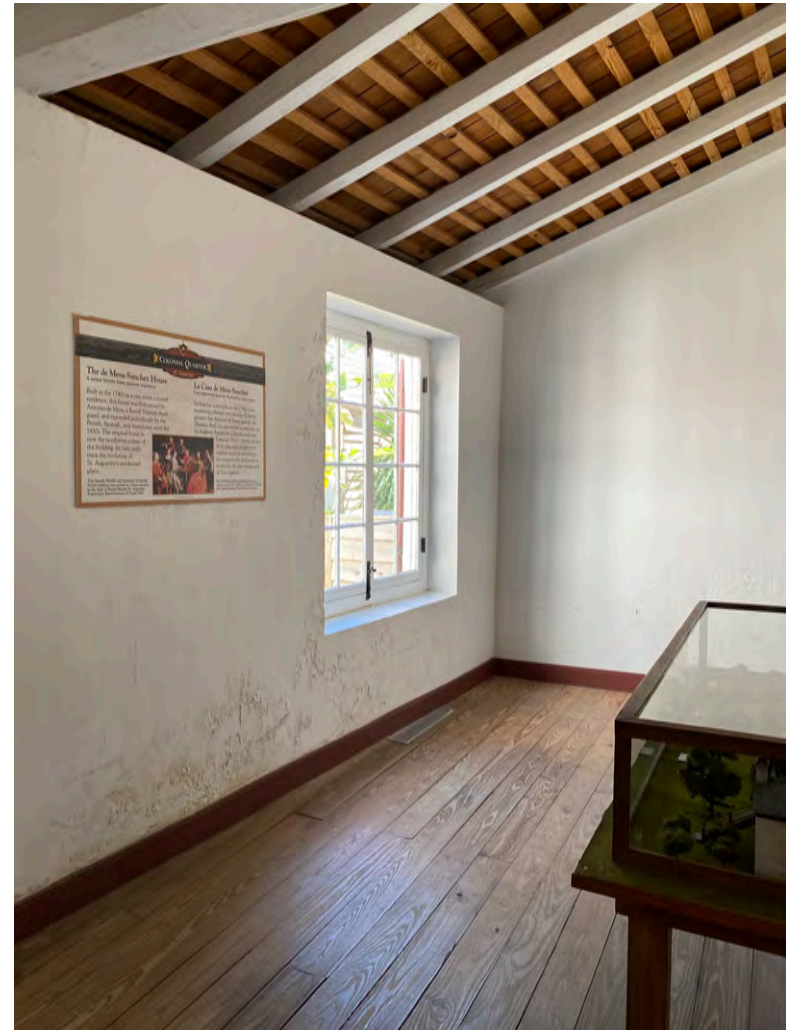
In the Fall of 2020, the UF HP Program research team and representatives of Sarah Ryan Architects, Inc. performed research on the condition of the DeMesa-Sanchez House to prepare the 2021 publication "Flood Mitigation Design Guidance for Historic Coquina Buildings." Researchers emphasized that while DeMesa-Sanchez House experienced minor flooding effects in pre-2021 storm events, heavy localized rain poses a periodic concern. The building is air-conditioned, but not enough to cause vapor drive or condensation problems.¹⁴ However, the air conditioning's unique underfloor distribution system provides a potential pathway for water infiltration. The site is not walled and is open to adjacent properties. Of the three ground-floor door openings, the one on the West Wing's west façade has the highest threshold height, with the others are almost at grade level. The first floor suffers from rising dump issues in areas with minimal roof overhangs, and the floor of the kitchen addition is at grade level.¹⁵

DeMesa- Sanchez House, Room 104, east wall, looking SE, 2020. Photo: Sarah Ryan

Researchers acknowledged that the DeMesa-Sanchez House should be protected against future water damage. They suggest the protection by temporary measures, including removable pressure-fit floodgates at the three doorways. Installing a sump and pump to remove water infiltrating the air condition system would be helpful if the underground floor distribution system is inundated in future flooding events.¹⁶

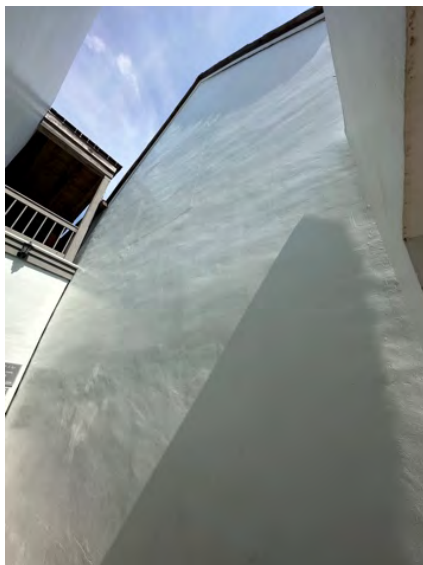
A: West Wing, N facade, looking SE and up.

As part of the work of the 1980 restoration, the building was returned to the Territorial Period appearance. These alterations included the enclosure of three windows on the north facade's first level and two window openings on the second level. There are ghost marks visible on the façade where these openings existed (A; B, C).

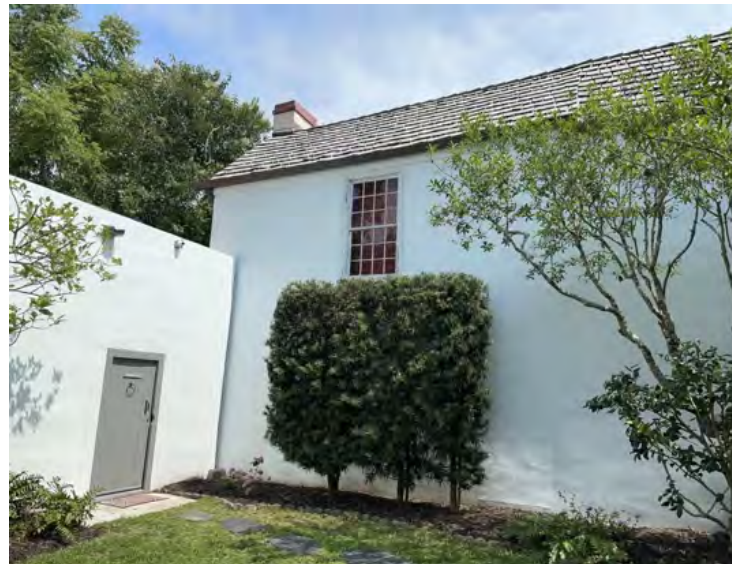
B: East Wing, N facade, looking SE and up.

There is a twelve-over-twelve sash window on the second level of the East Wing's north façade (B). The window frames are painted white. There is a twelve-over-eight wood sash window on the westernmost section of the north façade. The operable shutters, painted dark brown, flank the westernmost window.

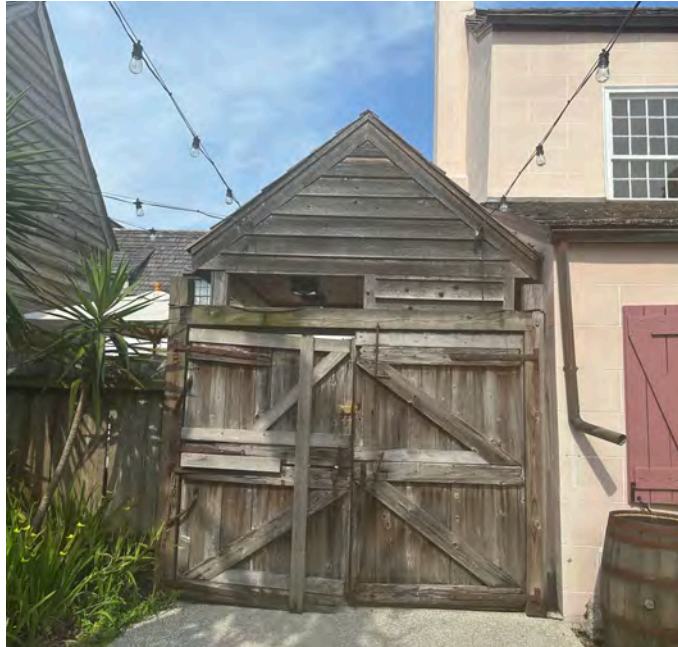
B: Ticket booth, looking W

The wood ticket booth and taller wood fence set back from the west property line are in fair condition. The south gate into the courtyard is sagging from the hinges. The placement of the ticket booth's north wall against the house west wing's south stucco wall may contribute to moisture damage in this location.

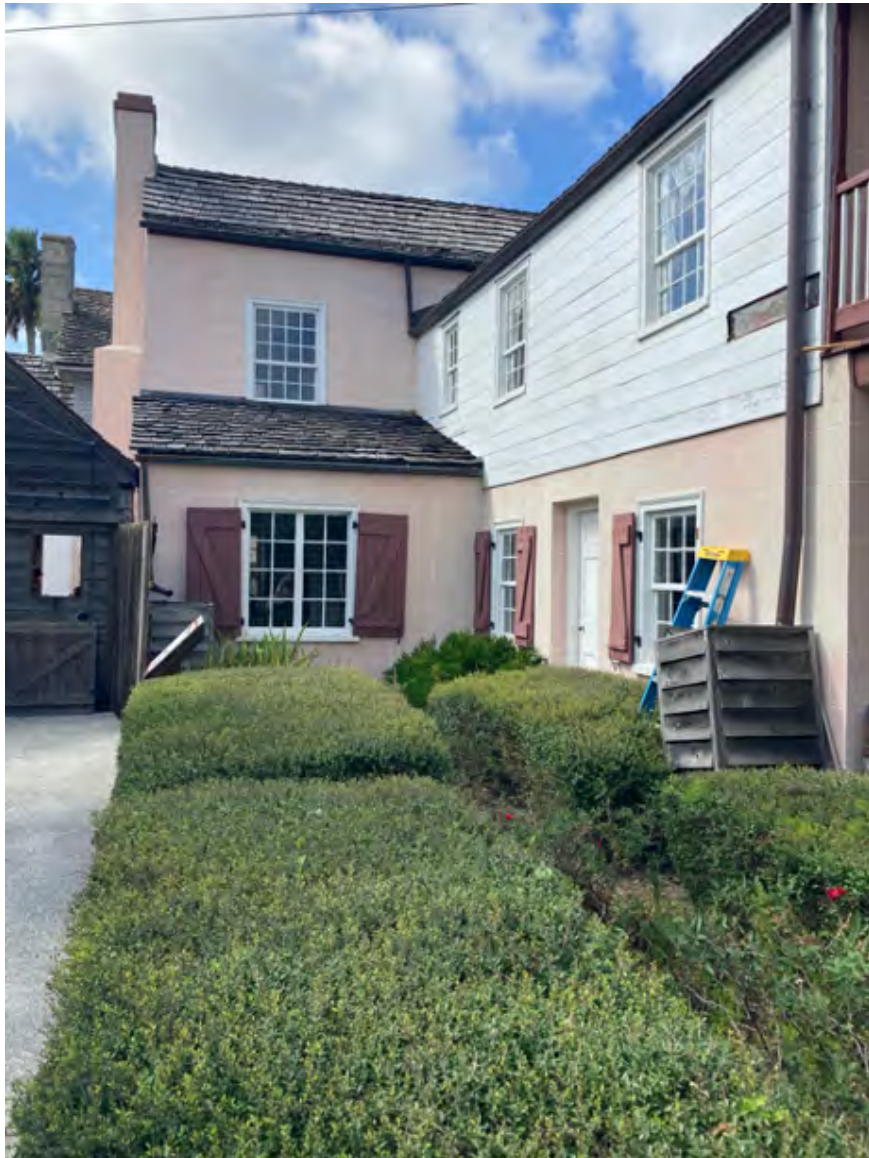
D: Plants along E and S facades, looking NW

Along the south and east walls of the building, some foundation plantings are too close to the masonry walls and serve to trap moisture.

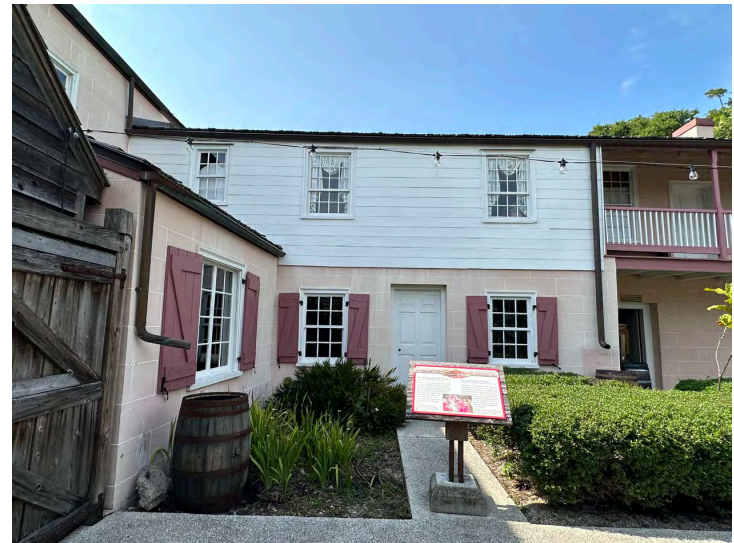
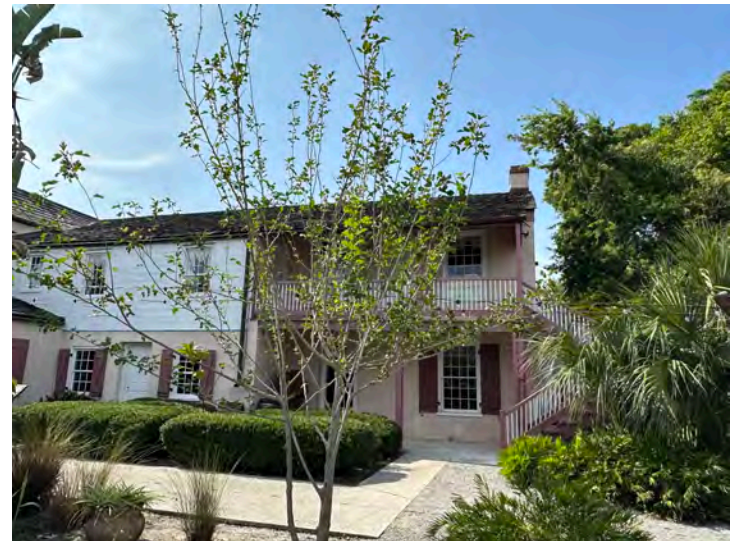
Some paving and site features impede site water flow away from the building. The westernmost concrete walkway that leads to the south façade should be either removed or replaced to promote drainage of water away from the building.

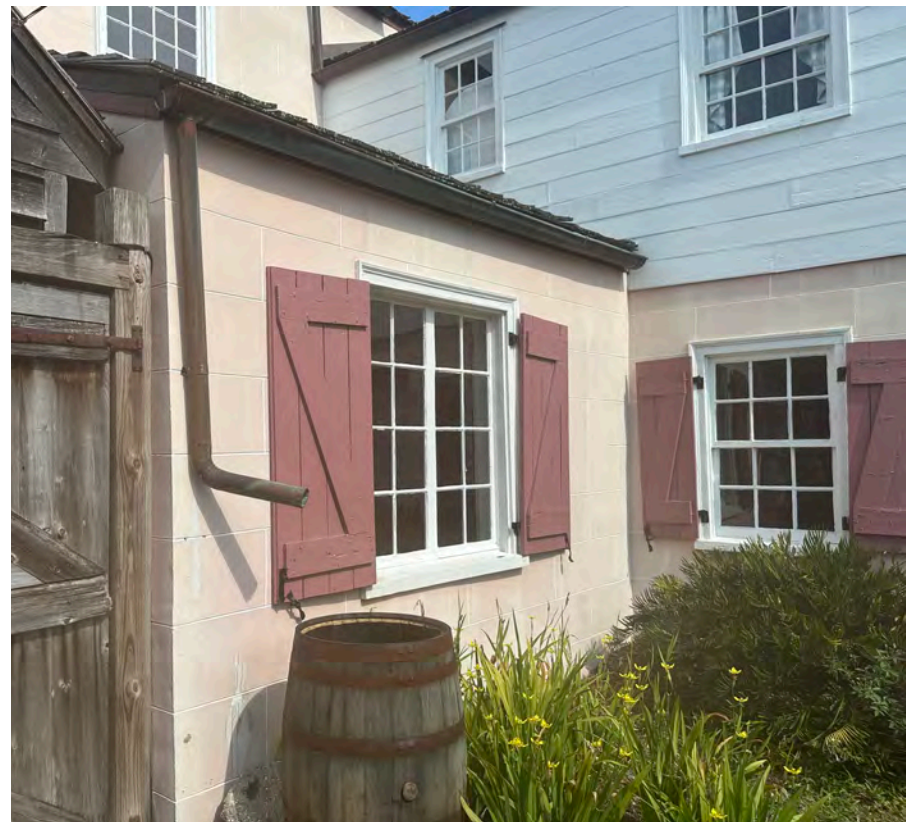
C: West Wing, roof's Eslope, looking NW and up

Overall, the flashing materials appear to be in good condition at the chimney/roof penetrations at the east chimney and the south chimney. The drip edges appear secure and in good condition. The gutters and downspouts appear to be well-fastened and in good condition (C).

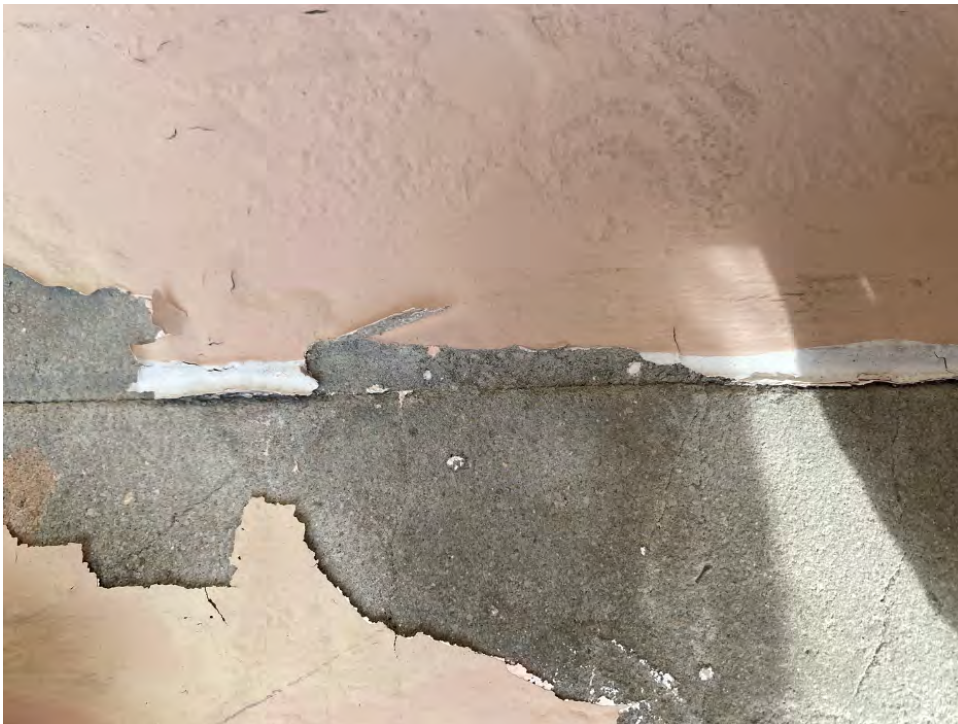
B: East Wing, S facade, looking N

Overall, the painted stucco on the east wing's south and east façades is in good condition. There is some minor fading of the paint color in various locations. There are a few areas of mold discoloration and wear, mostly near the ground level (A, B, C).

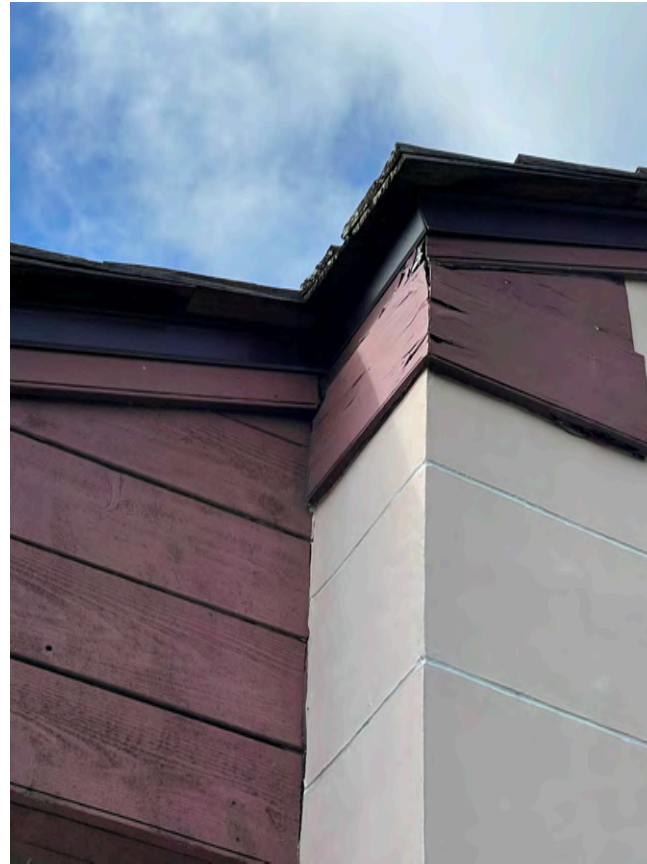
E: West Wing, Balcony, looking NE and up

Most of the wood elements of the balcony are in good condition (A, B, C, D). The woodwork applied to the façade at the upper south-west corner displays some minor damage and chipped paint (E).

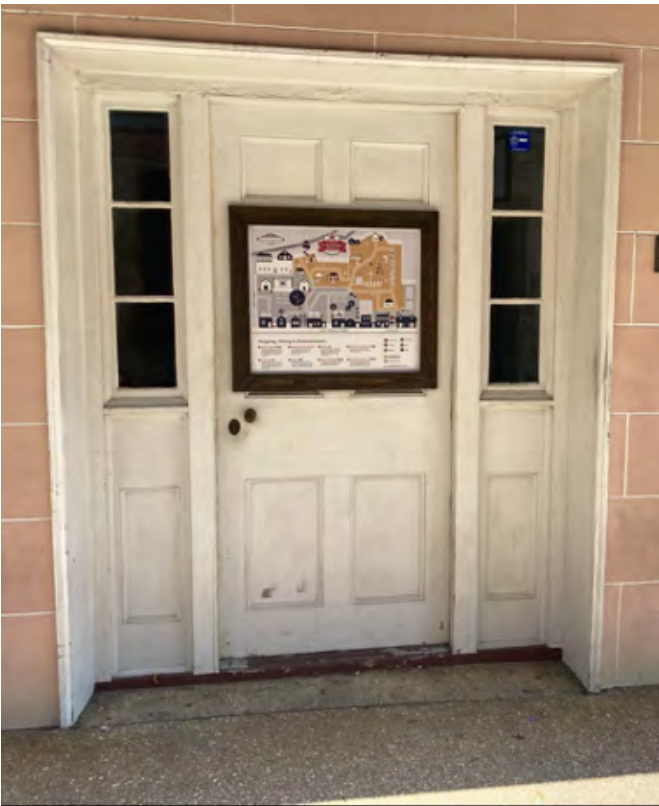
B: Door D1 West Wing, W facade, looking NE

The west entrance door, frame and sidelights (D1) are in overall good condition (A). The wood sill has some areas of chipped paint, and the lower sections of the frame have minor evidence of wea (B)..

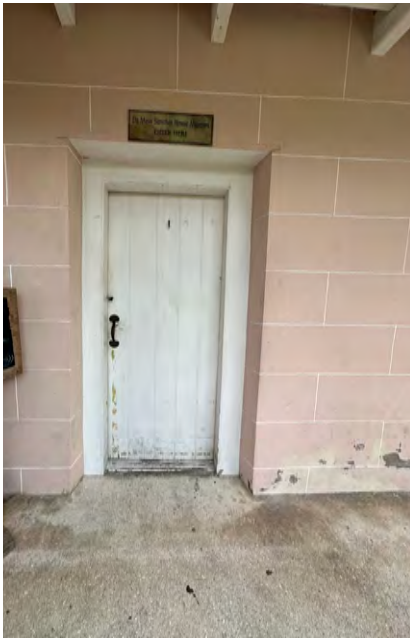
A: Door D11 East Wing, S facade, looking N

The south façade, east-side door and frame (D11) are protected by the Loggia above (A, B). The paint finish exhibits some chipping, especially at the wood sill and lower area of the door casings, and the bottom of the door planks indicates some moisture absorption into the wood.

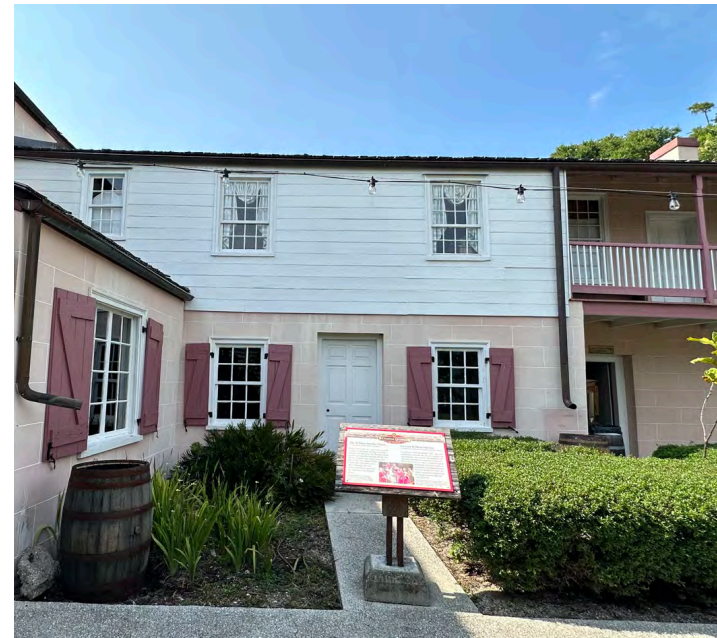
C: Door D13 East Wing, S facade, looking N

The south façade, west-side door and frame (D13) are in fair condition on the exterior (C). The interior face of lower wood panels indicates significant rot and damage to the painted wood.

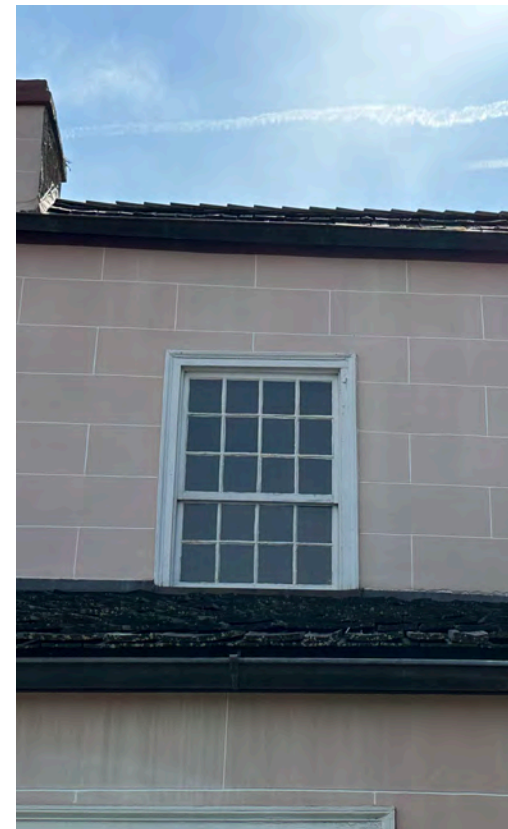
B: West Wing, E facade, window 2E6 looking W

Window 1E2 is in good condition (A). Window 2E6 is in good condition (B)

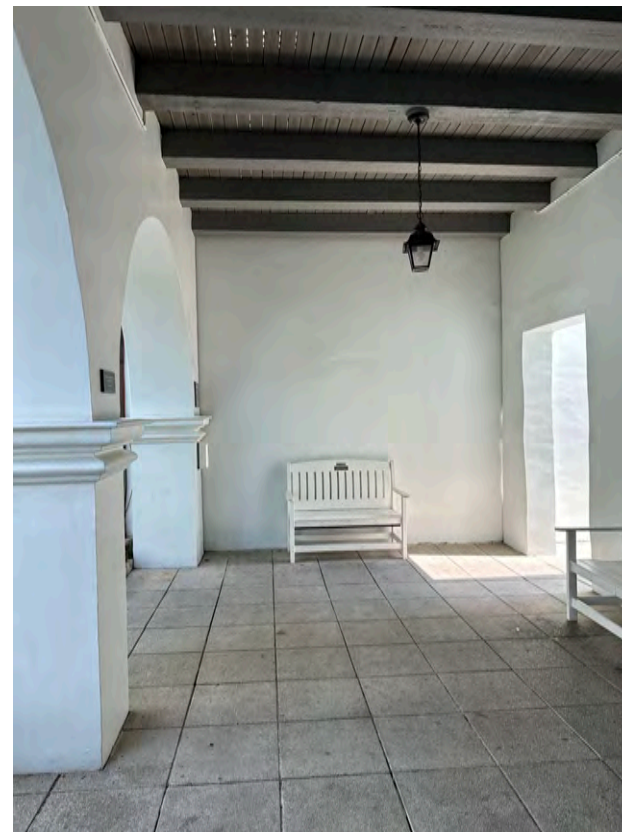
B: East Wing, N facade, looking S Window 2N1, not accessible for viewing

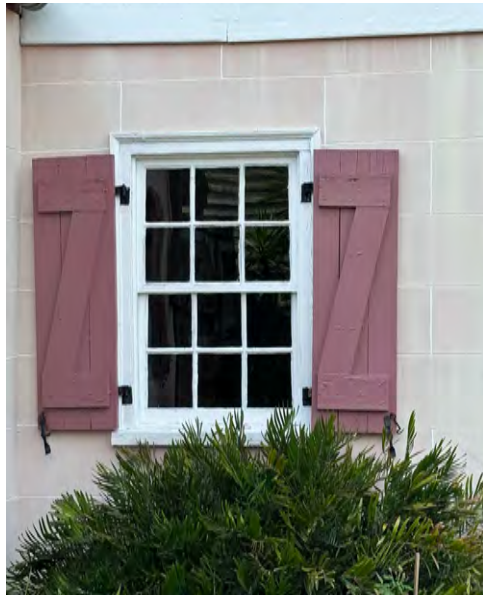
Shutters at windows 1S1, 1S2, 1S3 are in good condition (A, B, C).

A: East Wing, window 1S3, looking N

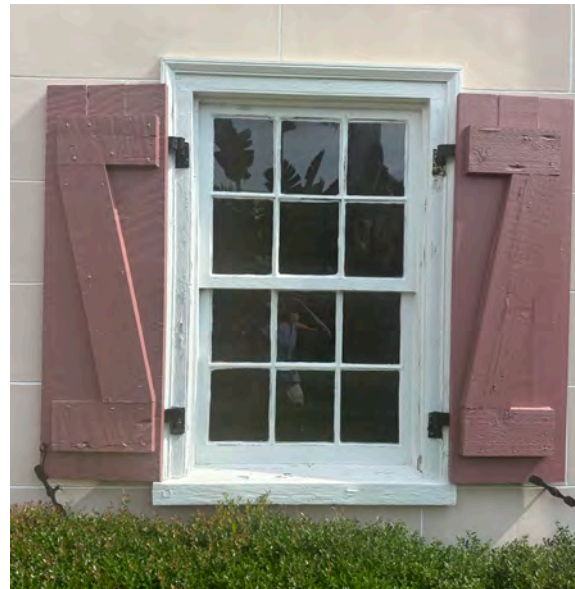
Window 1S2 is in good condition, with minor chipping and small amounts of loss of glazing putty in upper sash (B).

B: East Wing, window 1S2, looking N

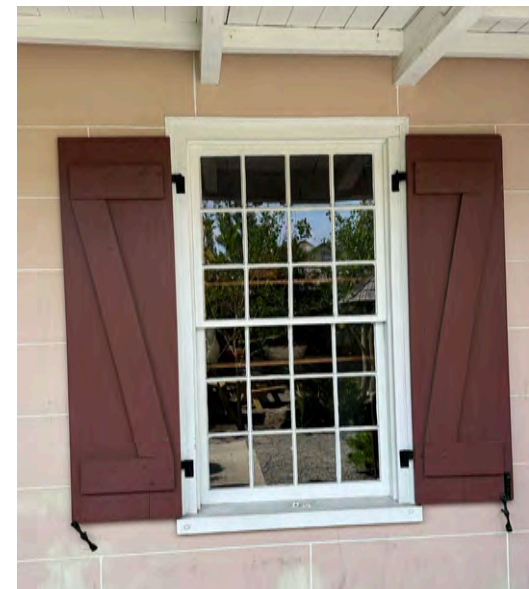
Window 1S1 is protected under the loggia floor and roof above and are in good condition (C).

C: East Wing, window 1S1, looking NE

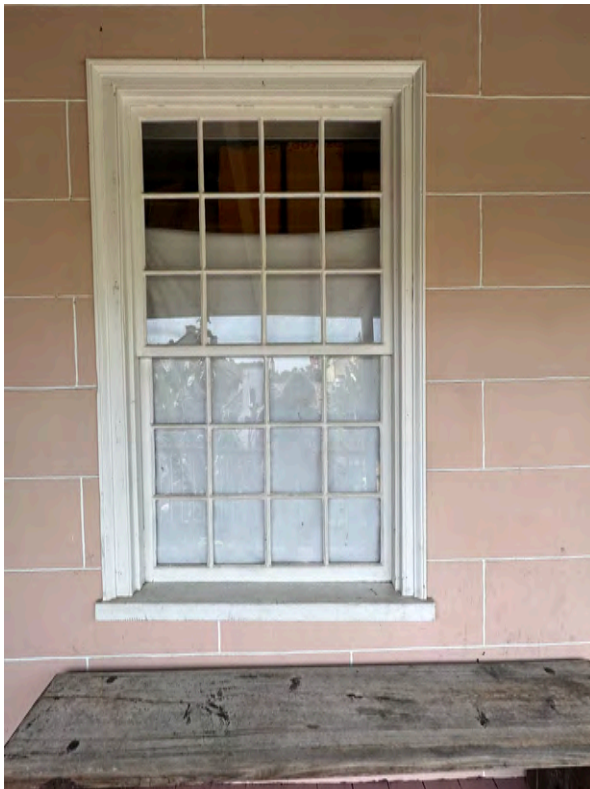
2S1 and 2S2 are protected by the Loggia roof and are in good condition (A, B).

A: East Wing, window 2S2, looking N

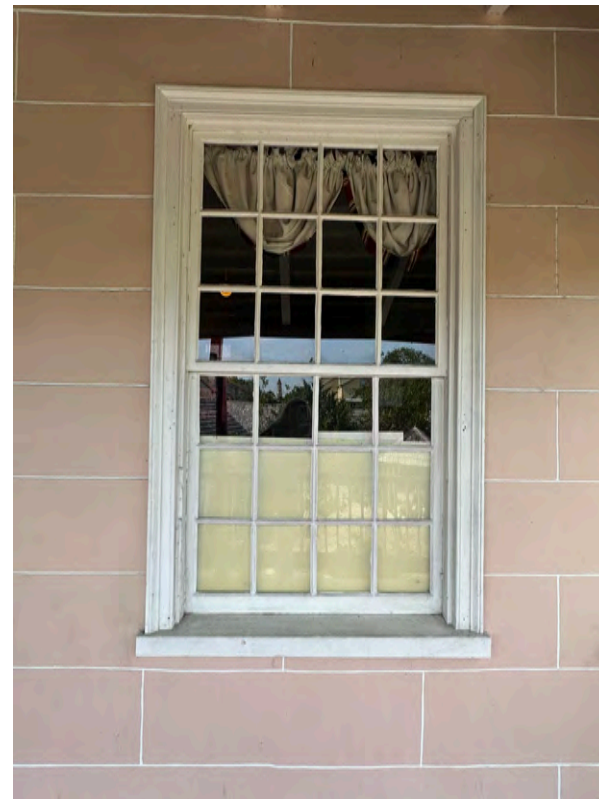
B: East Wing, window 2S1, looking N

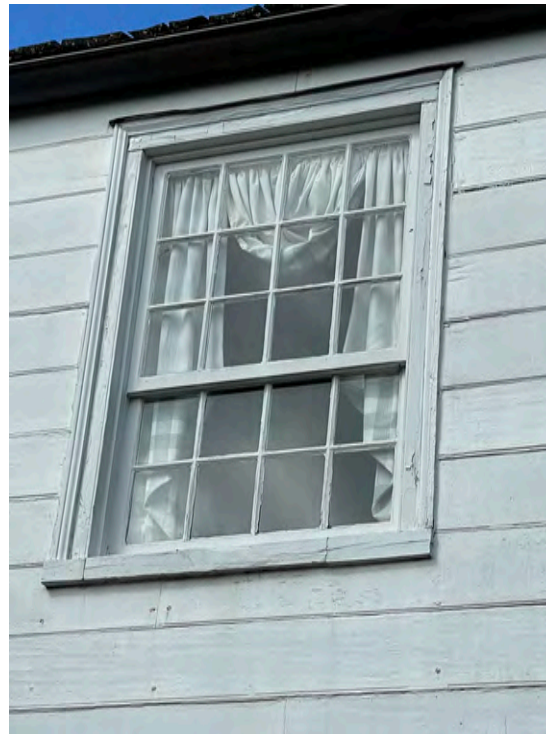
Window 2S4 is in overall good condition, there is cracking and splitting of the wood of the projecting sill piece (B).

B: East Wing, window 2S4 looking NE and up

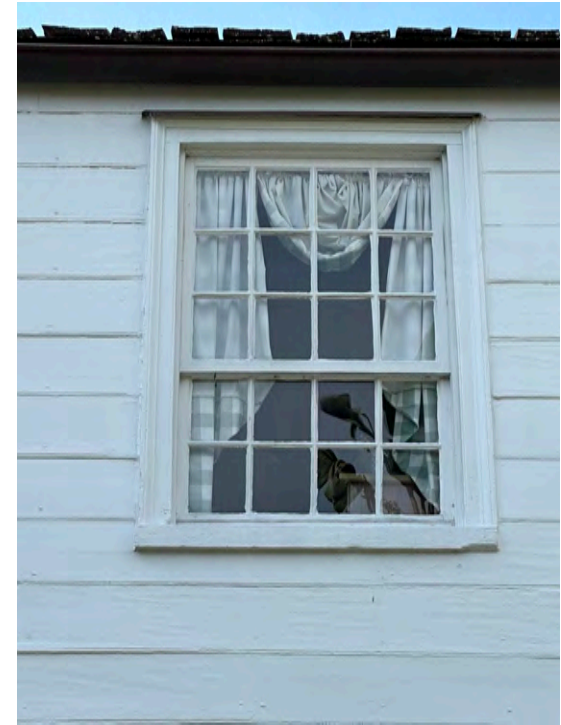
.Windows 2S3 and 2S5 appear to be in overall good condition (A, C).

C: East Wing, window 2S3, looking N and up

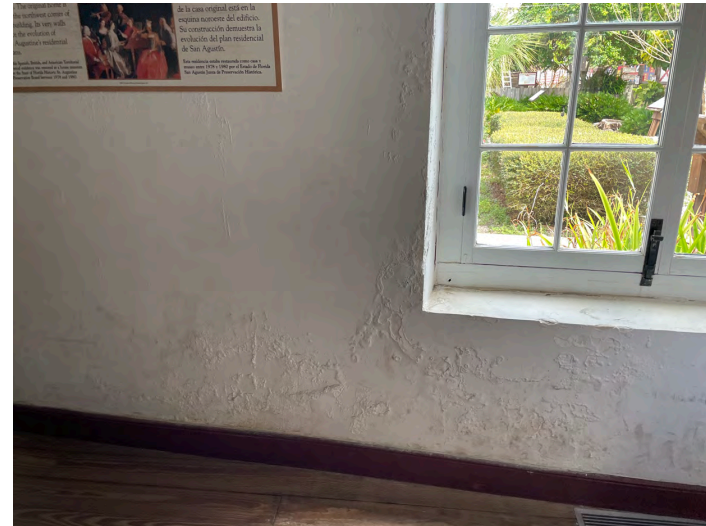
A: Room 104, E wall, looking SE and down

- Evidence of painted plaster wall deterioration, which may indicate underlying moisture issues in the coquina masonry walls. There is evidence of moisture in the lower level of the masonry walls, especially noted in the internal masonry wall between spaces 106/108 and room 107. The south walls of the East wing also present evidence of moisture intrusion. See notes below for some specific locations of this damage (A).

- The mechanical system air delivery was designed for air ducts run in trenches under the restored lower level floors (A). This may become a future issue due to increased storm activity and rising water levels. See Recommendations section.

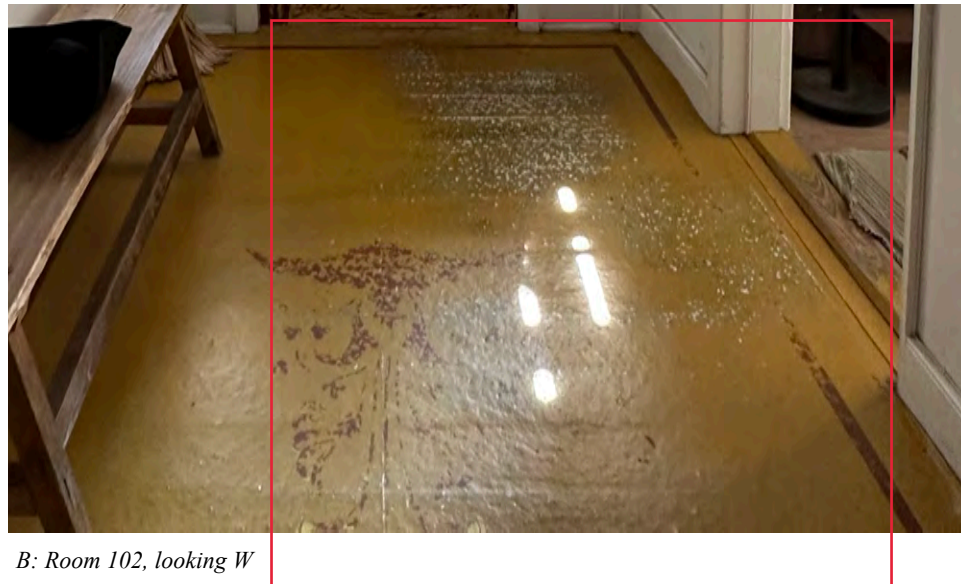
B: Room 102, looking W

Painted ornament on the wood floor is fading away (B).

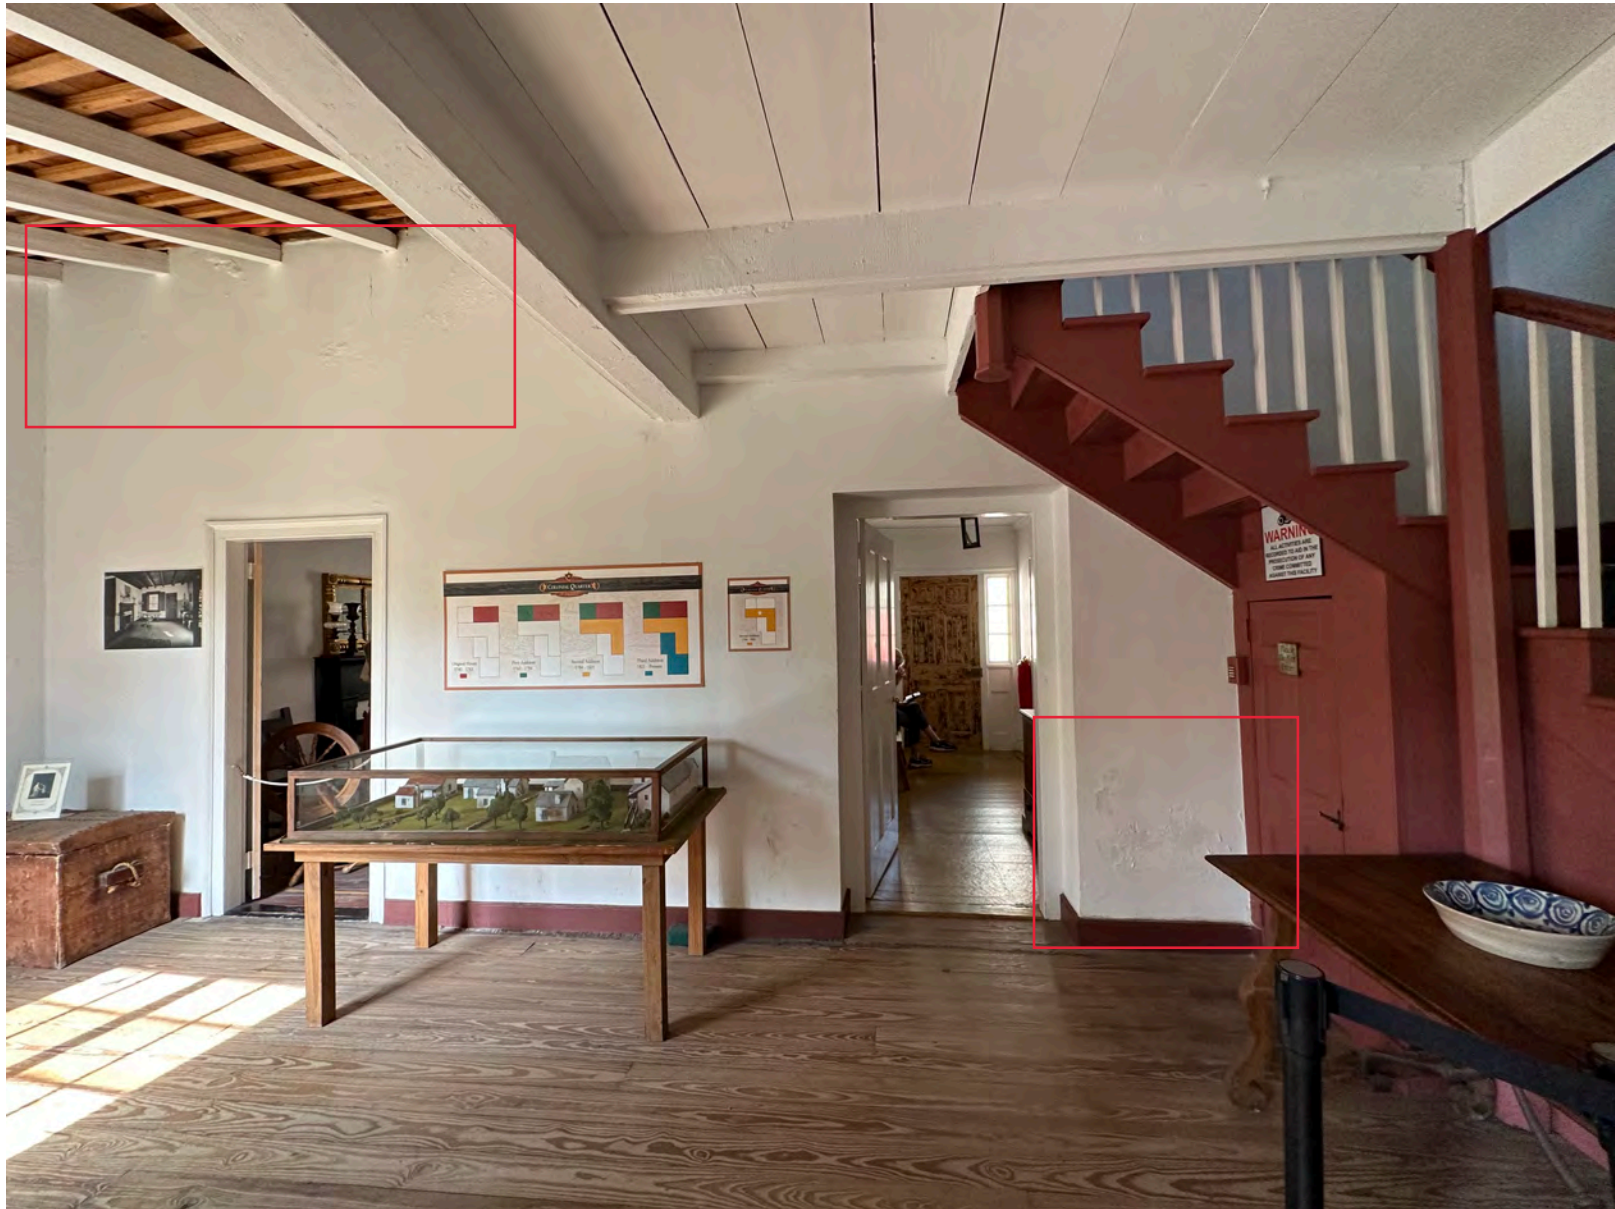
A: Rooms 104 and 105, looking SW

This space has several areas of damage to the plaster walls, indicating moisture infiltration in the masonry wall:

- west wall, high on the wall under the exposed beams (A)
- west wall, low on wall next to the wood staircase (A)
- south wall, low on wall below sill height (B)
- east wall, around the window opening (1E1), more extensive plaster damage along the wall below the window sill height (C)

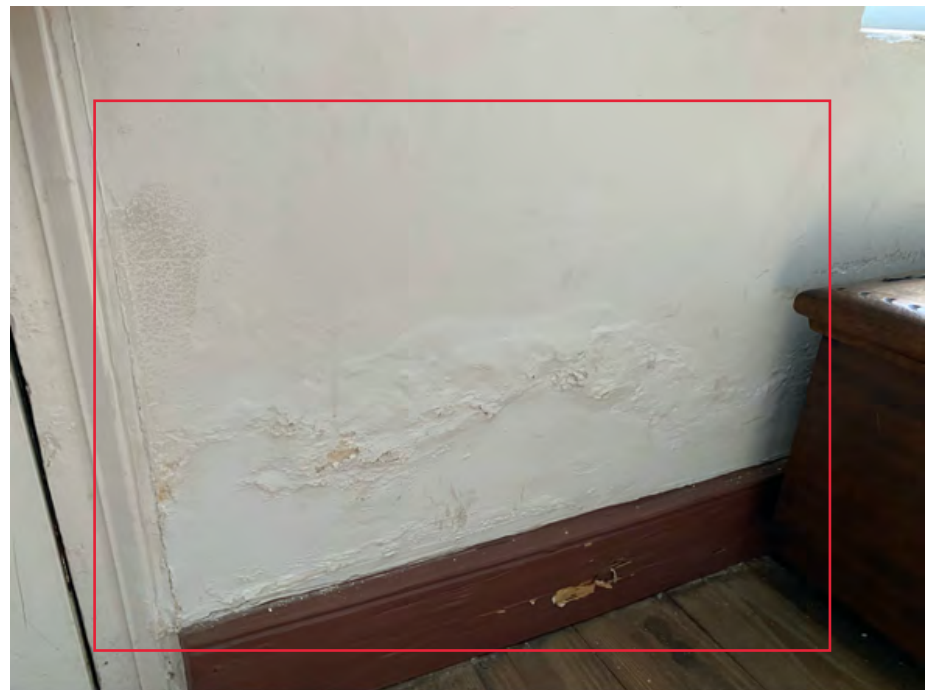
B: Room 107, looking SW and down

Plaster damage on north wall and low on the south wall (A, B).

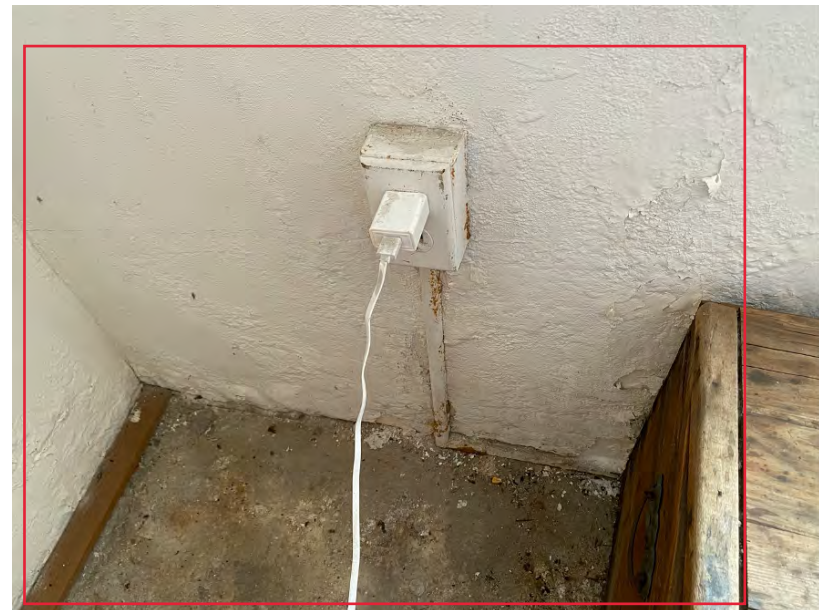
B: Room 110, looking S and down

Plaster damage at south and east walls (A, B).

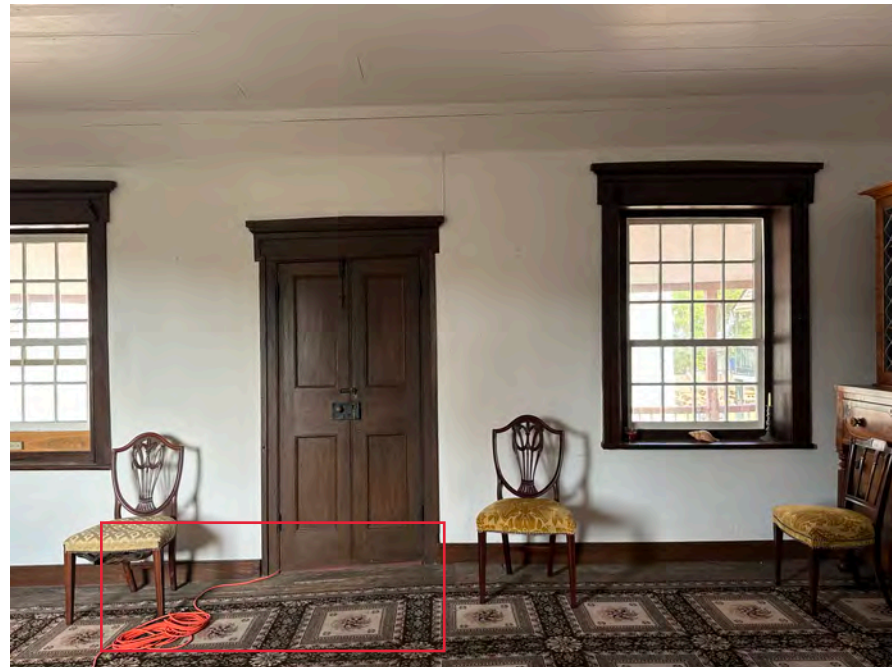
A: Room 201, looking W

No adverse conditions were noted on wood ceilings, plasters walls, woodwork, fireplace or wood floors. Window 2W1 has a power strip inserted in the board that displace the lower sash, and a temporary power cord is run through the room under the Loggia doors to the exterior.

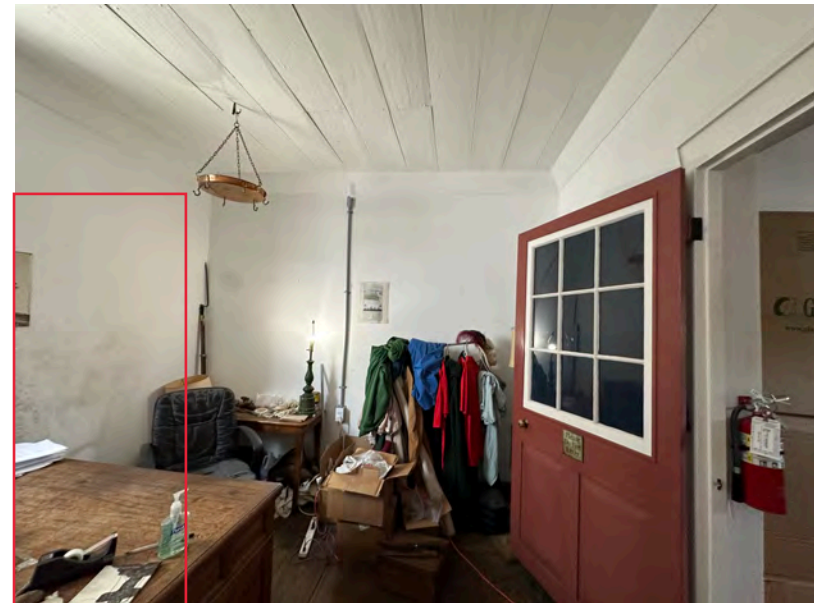
B: Room 206, looking E

Limited visibility, plaster damage on the north (exterior wall), and around the window 2N1 sill area (B).

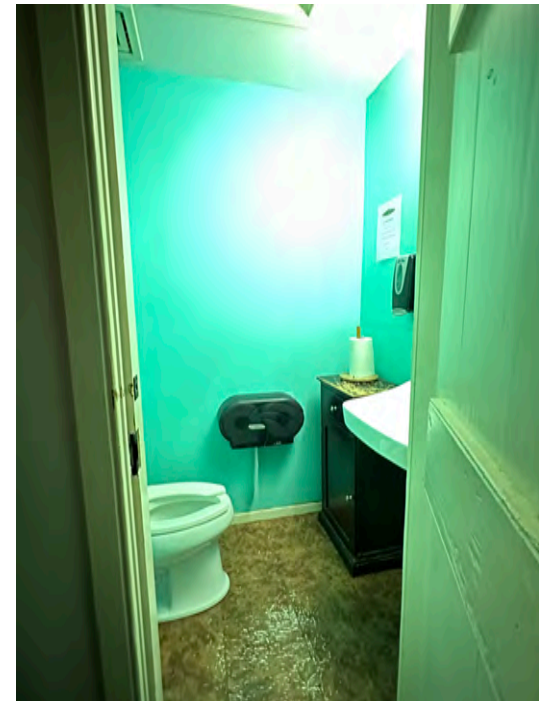
E:: Room 208A looking NW

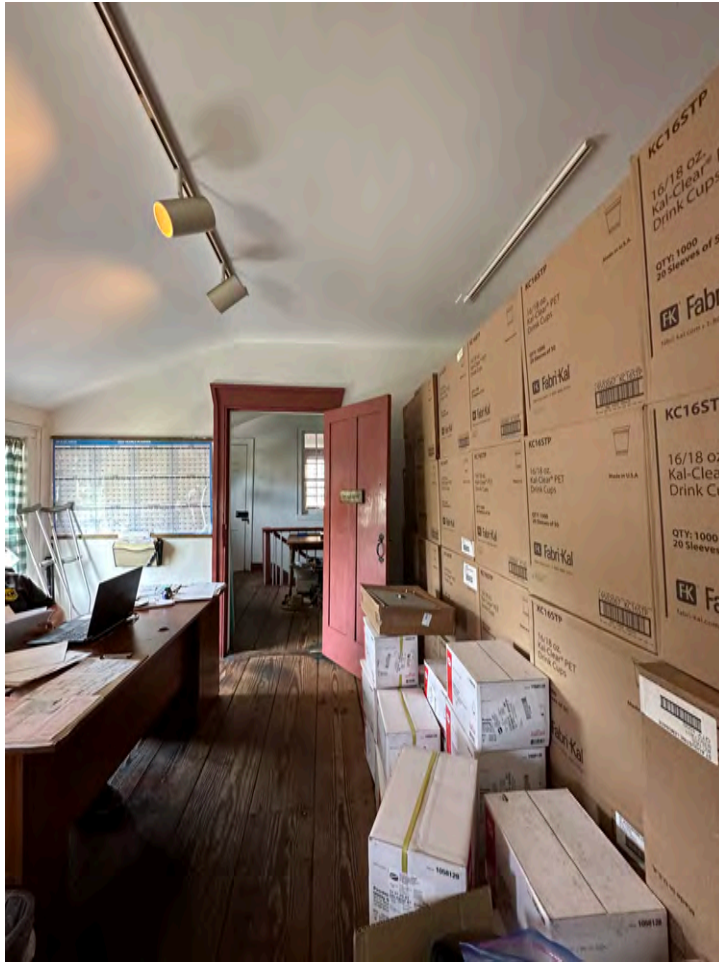
A: Room 207, looking W N

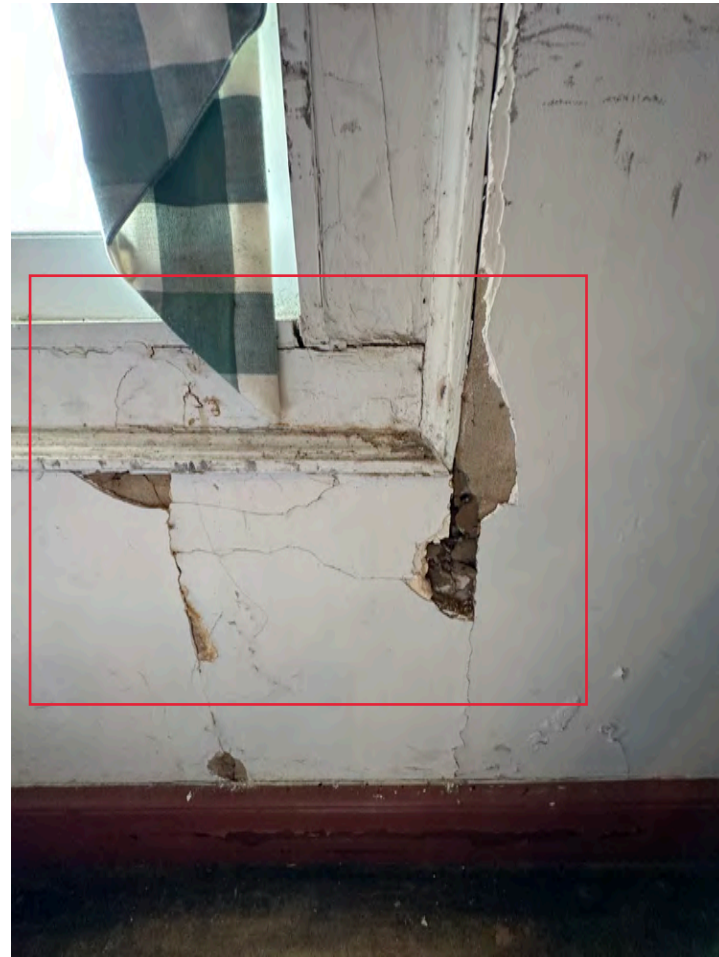
B: Room 207, looking S

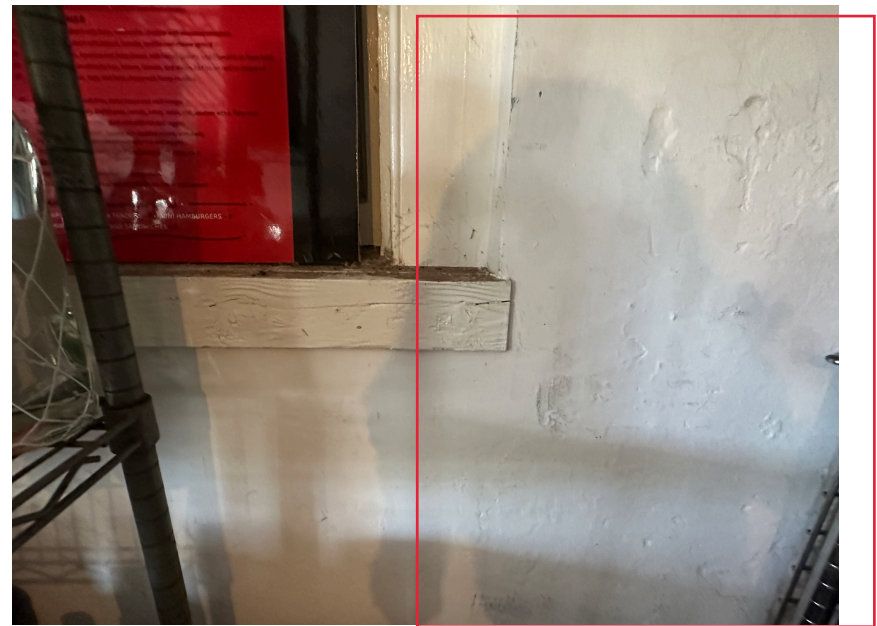
Limited visibility due to contents of space, plaster damage at ceiling near north wall (A, C) and near the window 2N1 (B).

B: Room 210, window 2N1, looking N

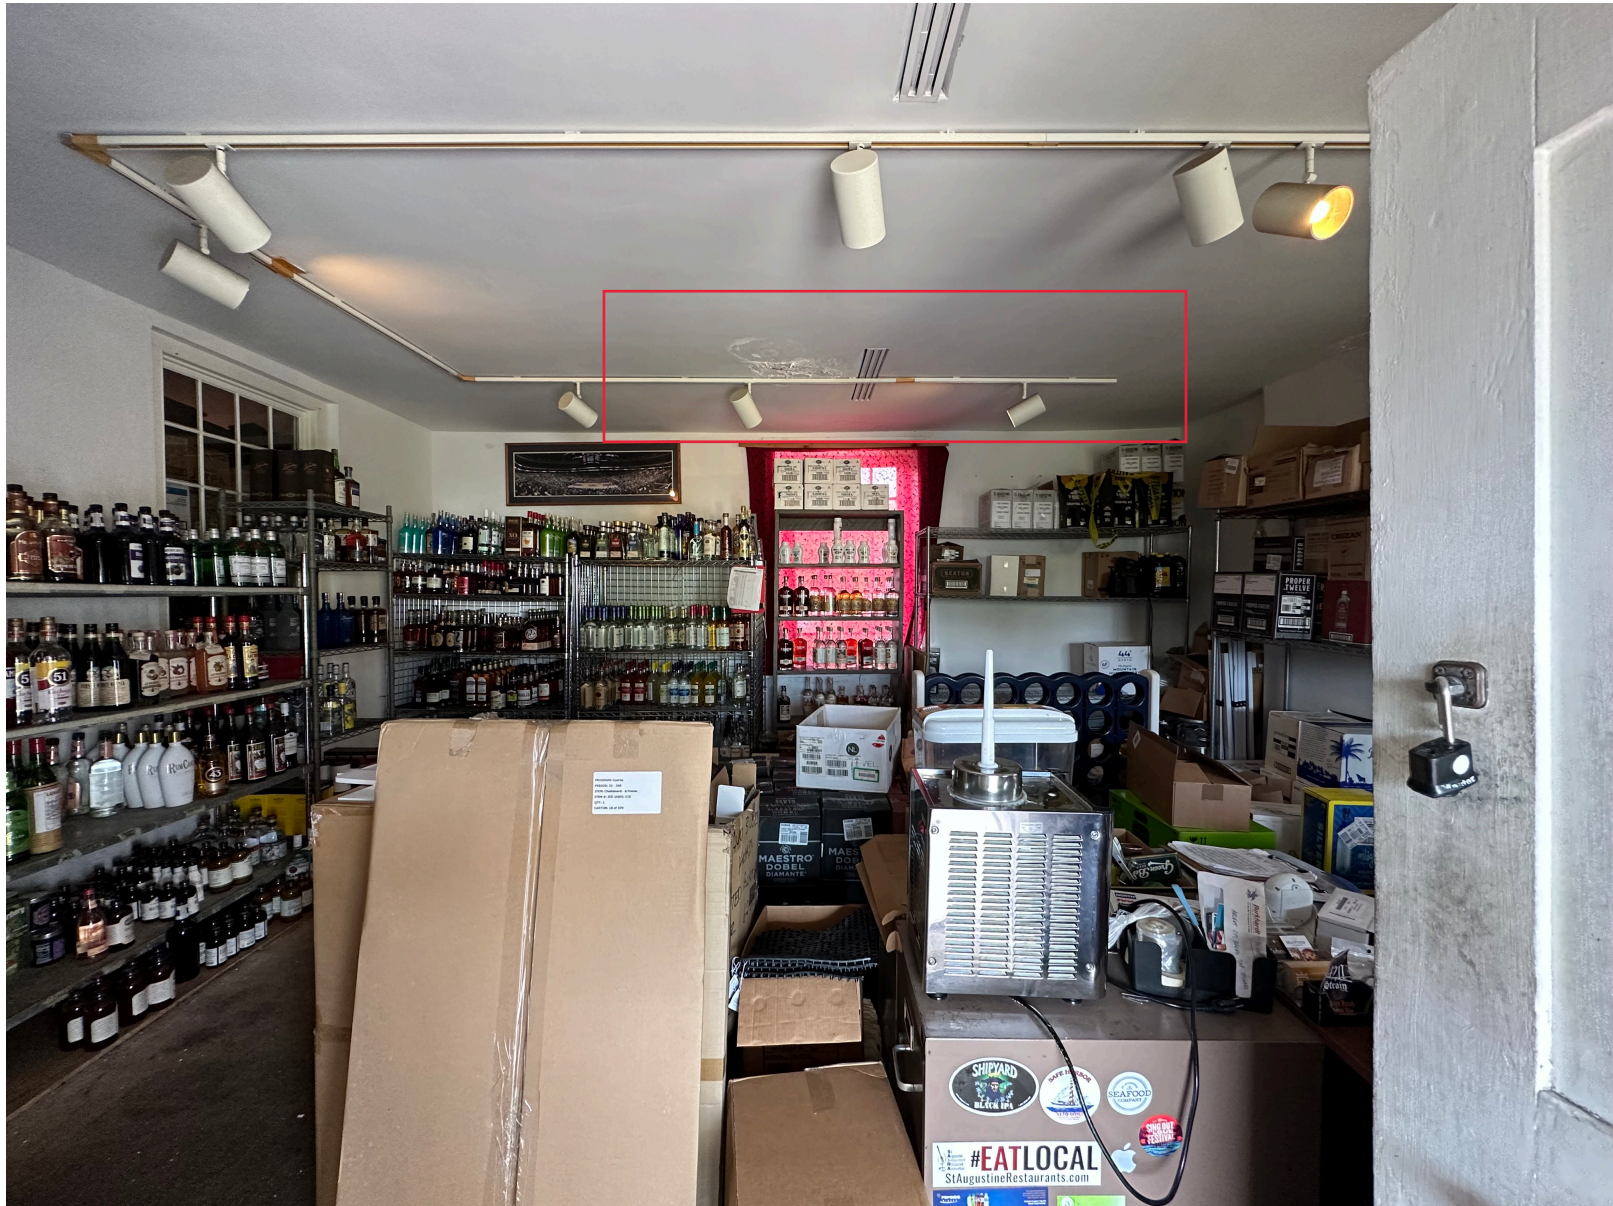
C: Room 210, looking N
