THE DEMESA-SANCHEZ HOUSE

43 St. George St. Augustine, Florida

HISTORIC STRUCTURE REPORT

Historic Preservation Program, DCP, University of Florida

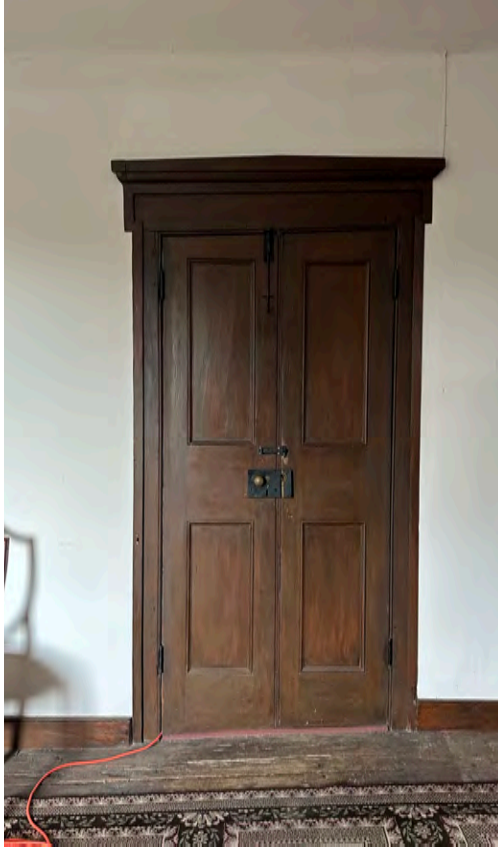
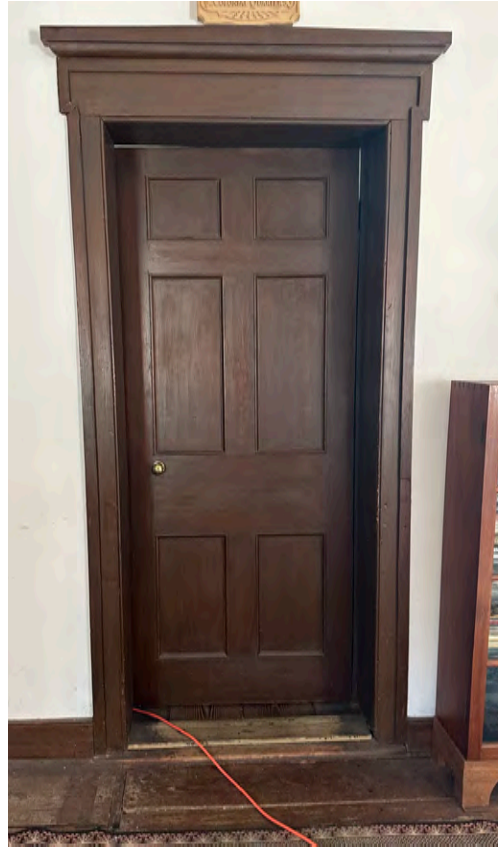
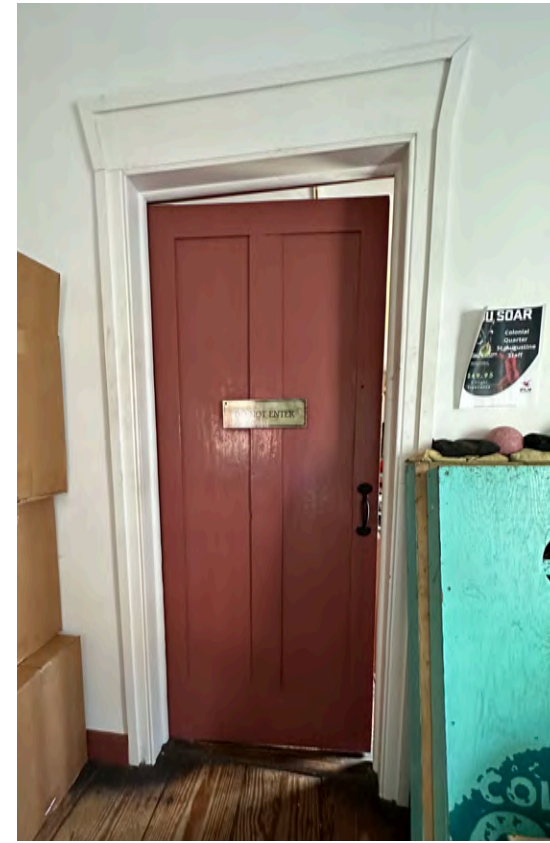
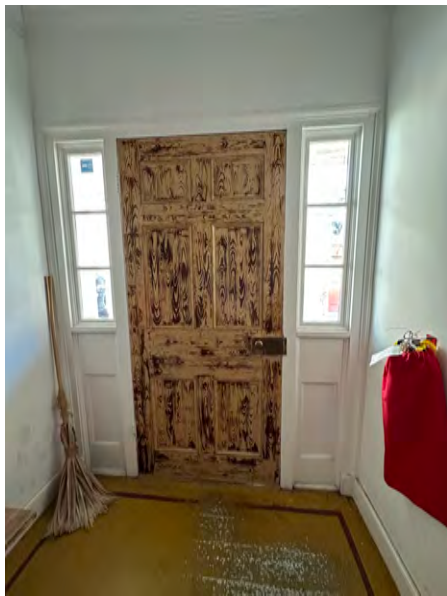
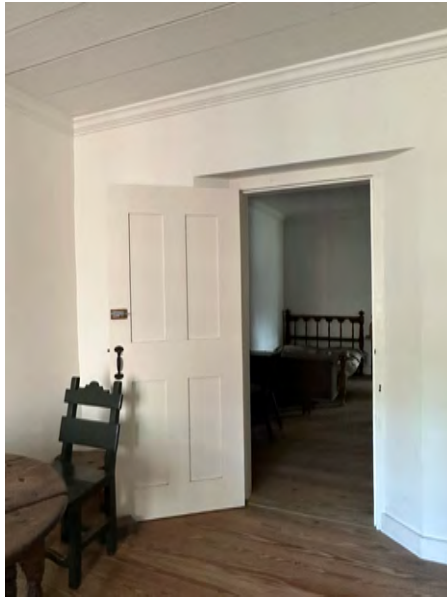
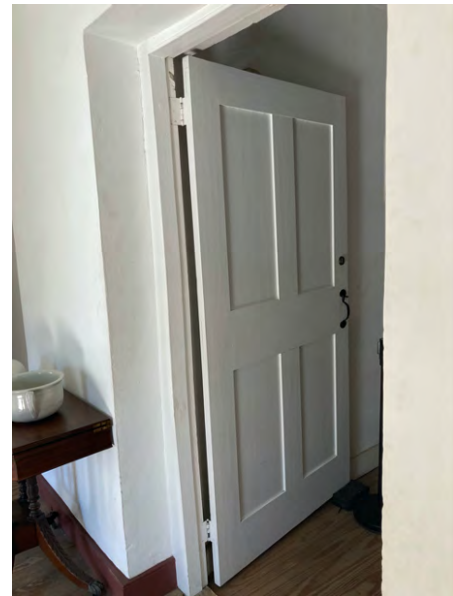
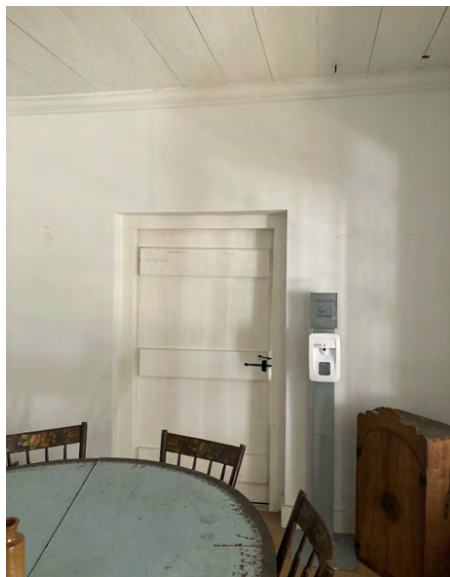
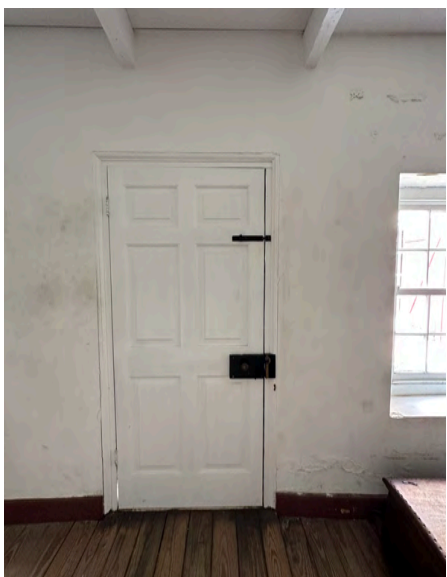
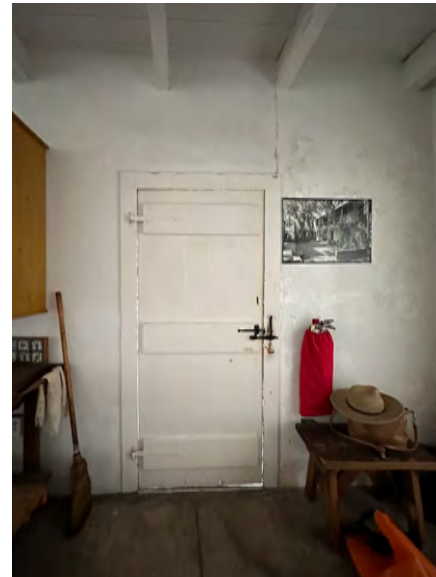
Overall, the interior wood doors are in good condition.

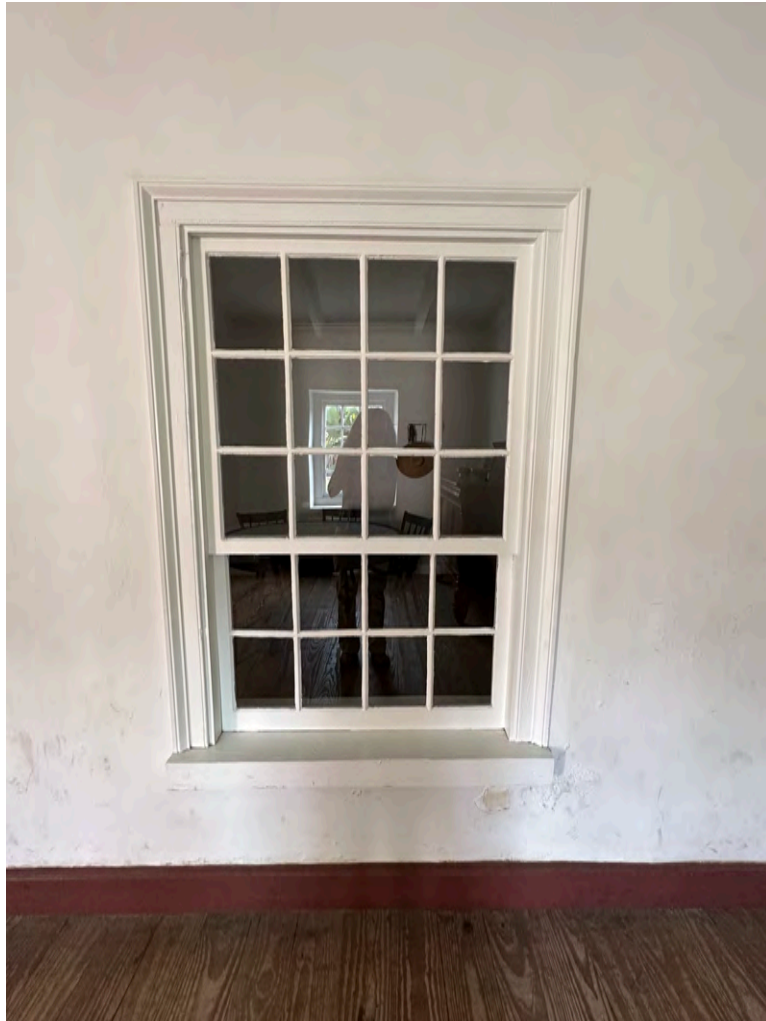
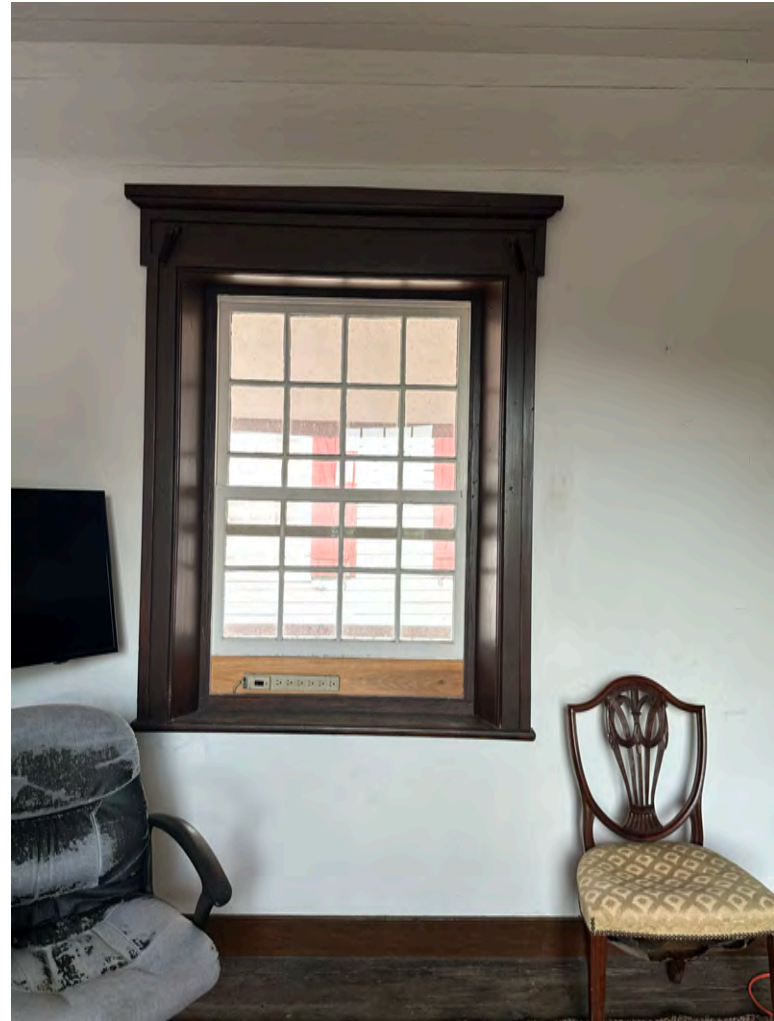
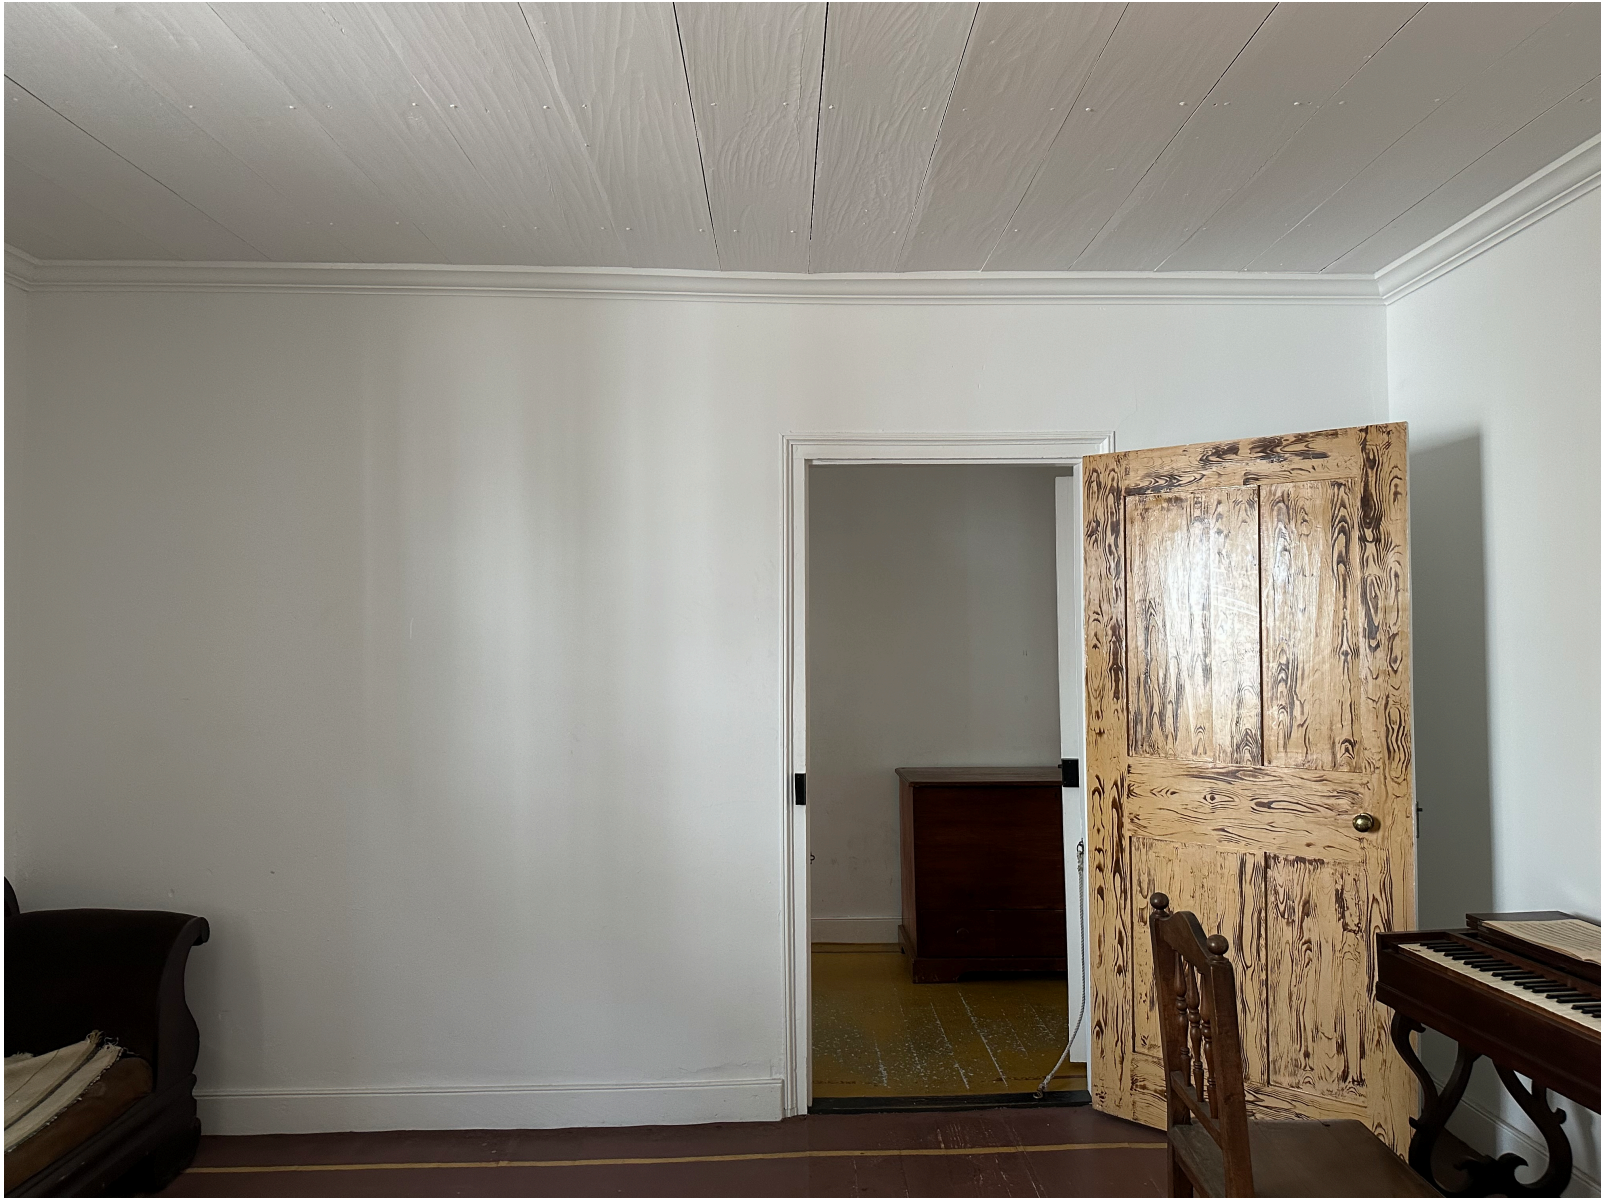
Overall, the interior woodwork is in good condition

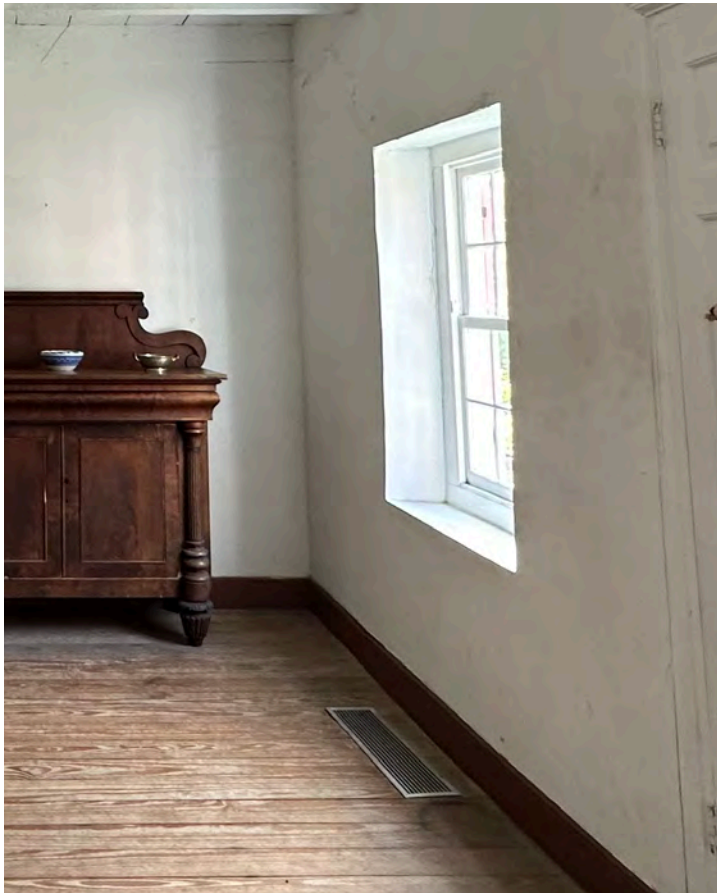
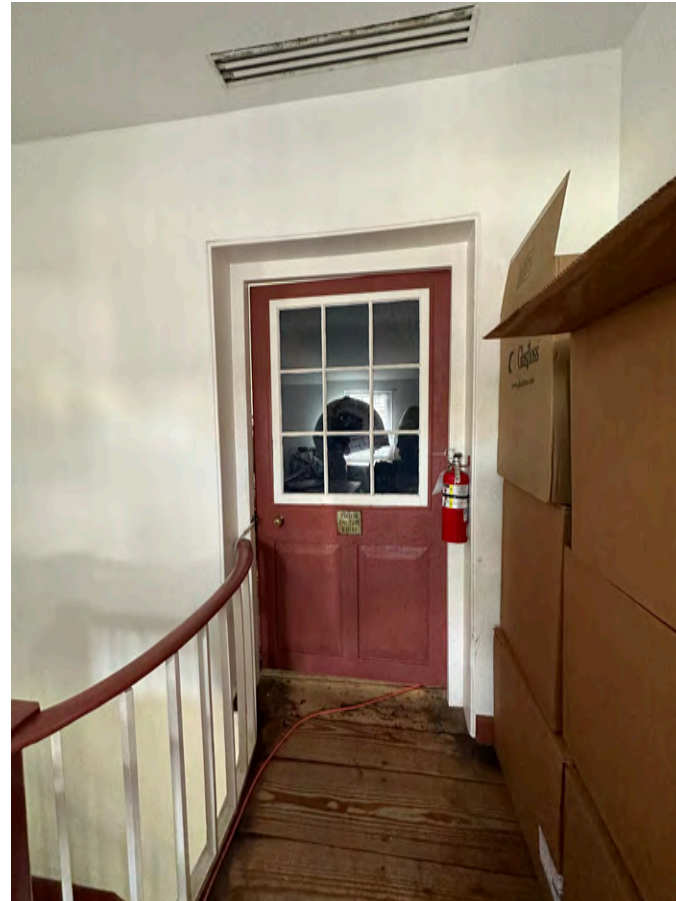
The most visible component of the mechanical system are the supply grills embedded in the first floor wood and concrete floors, and the grills in the second floor wood or plaster ceilings (A, B). The system was in operation on the date of the site visit. See Recommendations for future considerations for the mechanical system.

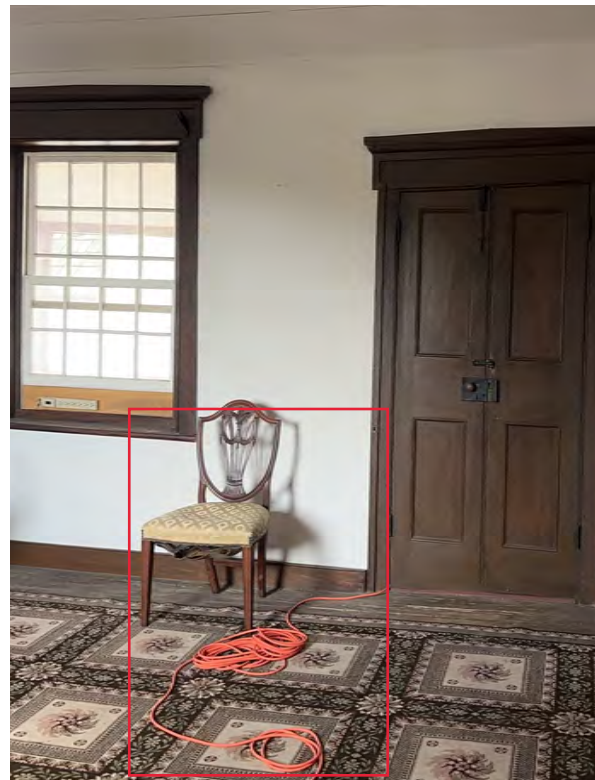
B: Room 201, looking SW

Room 201 had a temporary power cord running to the door at the balcony, then to the exterior for lighting (B). See Recommendations for future considerations for the electrical system. Power cords are running from the Room 208 (C). Consider future system adaptations for a more permanent solution to electrical needs for the building.
