# Paredes-Dodge House

HISTORIC STRUCTURE REPORT  
2017-2019

ST. AUGUSTINE, FL

Field Investigation: 2017-2019  
Publication of Report: Spring 2021

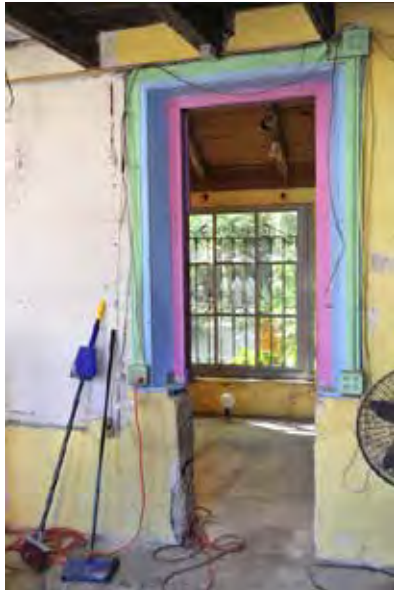
and northwest room used to be a window, but its sill and under wall were removed (Figure 4) between 1994 and 2017. [2] It provides additional evidence that the west section is a later addition.

Figure 4. Converted window.  
Photo by Marla Holden, 2018.

[2] The UF’s 1994 drawing (Figure 2) shows the windowsill while the 2017 documentation class found it removed (Figure 4).

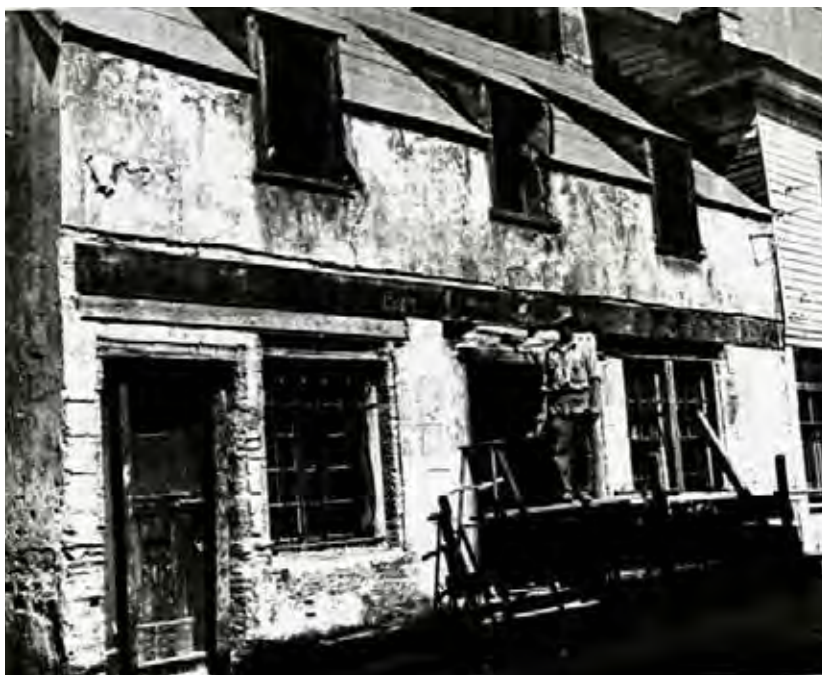
Figure 11. Façade during stabilization process. Photo. c. 1948. From University of Florida Digital Collections, *Paredes-Dodge House – 21 Black & White Print Copies*. <https://ufdc.ufl.edu/AA00011620/00026/8x> (accessed October 10, 2019).

The St. Augustine Historical Society also performed structural stabilization in 1948, and the results have remained until today. An I-beam was added to the right side of the central entrance, which thus became narrower. A long steel plate (32' by 1') was inserted along the east wall (Figure 11) and anchored to the ceiling joists with tie rods to reinforce the structure (Figure

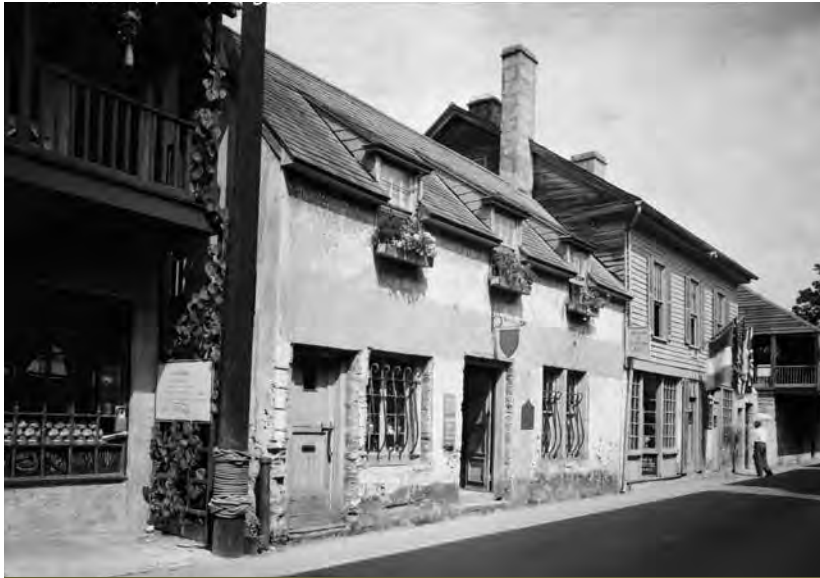
Figure 13. “Don Juan Paredes House.” Historic American Buildings Survey, in or after 1962 (based on Arrivas House’s restoration, at the right end). From Library of Congress, *Photo, Print, Drawing*. <https://www.loc.gov/item/fl0224/> (Accessed October 10, 2019).

12) ("III – History," n.d.). These were then covered with coquina blocks and stucco finish (Figure 13). The T-shaped stucco, sealing the horizontal and vertical reinforcements, appeared for a while until the façade got refinished. The exposure of the coquina around the openings, however, remained even after the repair.

[3] The present door was installed between c. 1962 and 1994. The c. 1962 HABS photo (Figure 13) shows the previous double-leaf, four-paneled door, while the UF’s 1994 drawing shows the present double-leaf, sixteen-paneled door. University of Florida. “Parades-Dodge House - East Elevation.” Drawing. Historic St. Augustine Preservation Board, January 25, 1994. From University of Florida Digital Collections, *Parades-Dodge House*. <https://ufdc.ufl.edu/AA00011935/00018/allvolumes> (Accessed August 31, 2017).

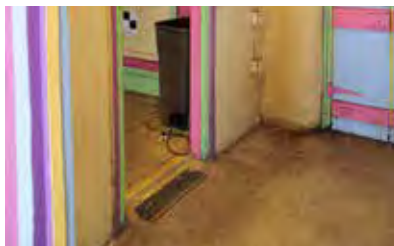
FS-03

At the central east doorway, tabby concrete is exposed and slightly eroded, presumably by pedestrian traffic.

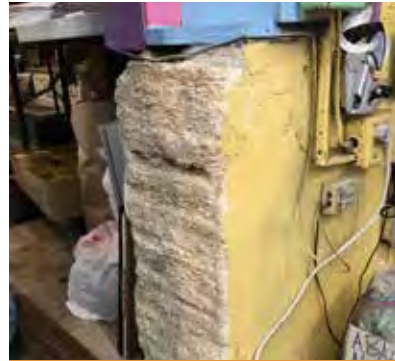
FW-02

The reinforcement wood frame on the east wall has rotted post bases to varying degrees, possibly due to the damp concrete floor.

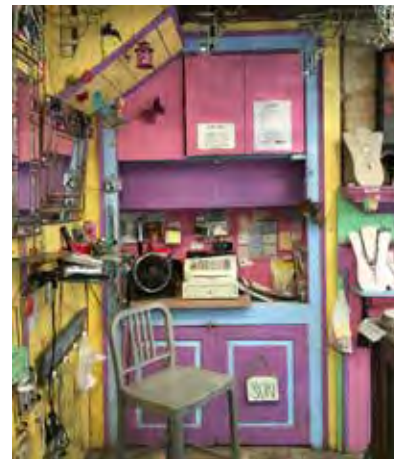
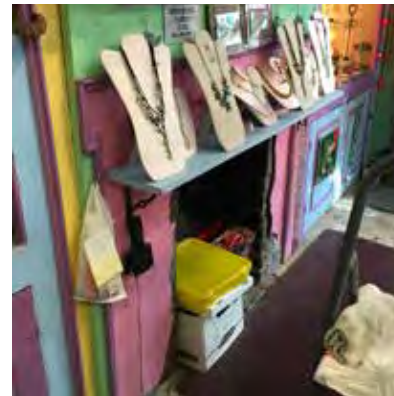
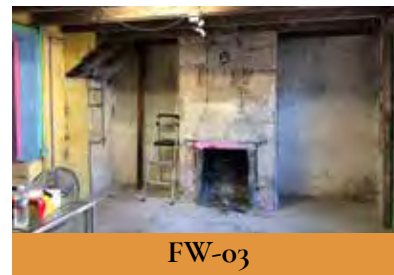
FW-03

The upstairs has been retrofitted with vinyl flooring and roof insulation. Whereas most of the interventions are reversible, the fireplace in the northeast room has lost its historic mantel and flanking cabinets, which were built in or before 1948, possibly from the original residence. Currently, a simple wood and plexiglass frame encases the coquina overmantel wall, and kitchen gadgets occupy where the cabinets were.

(Top and Middle) Room 101, North, 2017.  
(Bottom) Room 101, 2018.

The 2018 renovation demolished the two cabinets and the fireplace's wooden mantel.

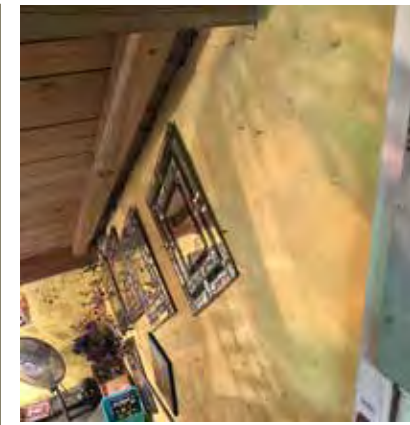
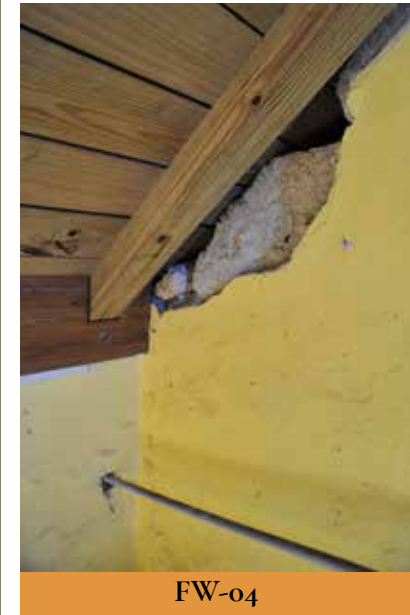
FW-04

A crack is present on the plastered surface of the staircase's north wall. The detachment of the plaster finish exists at the northwest top corner.

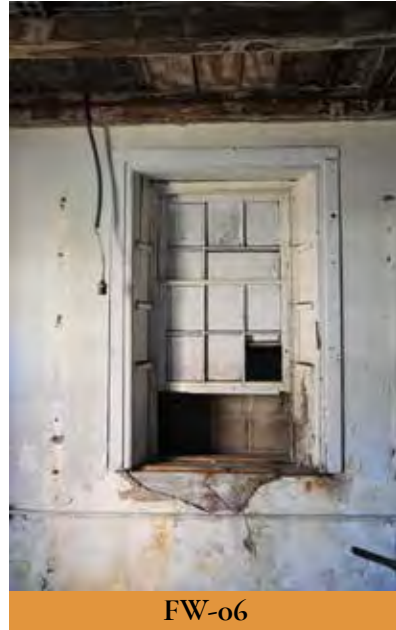
FW-06

The double-hung window is not in use due to the southern property's concrete-block wall built right beside the Paredes-Dodge House with a small gap. Tenants have blocked the window with such things as interior panels, curtains, and pictures. The sill and lower side jambs show decay. Below the sill, the cracked wall and detached plaster are present (2018 renovation covered it with wallpaper; repair is unknown.). It appears that the damage has resulted from water intrusion through the gap between the neighboring structures.

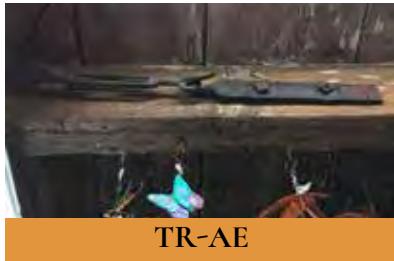
**TR-AE**

Five short tie rods anchor the east coquina wall and wood ceiling joists. They were part of the 1948 structural stabilization.

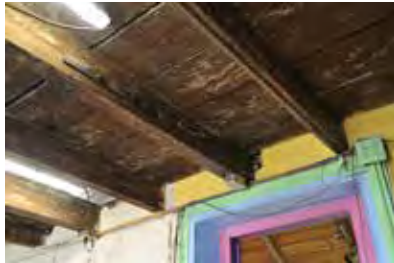
**TR-AM**

Four small tie rods fasten the joists to the mid-interior coquina wall (north-south) that was originally an exterior wall.

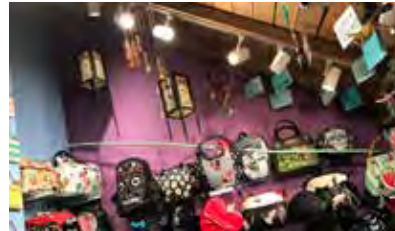
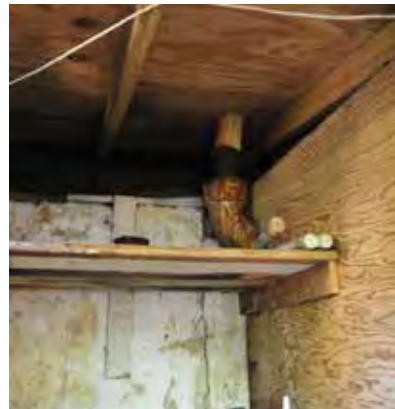
**TR-BL**

One tie rod crosses two rooms, 102 and 103, at the south end and anchors the east and west exterior walls together.

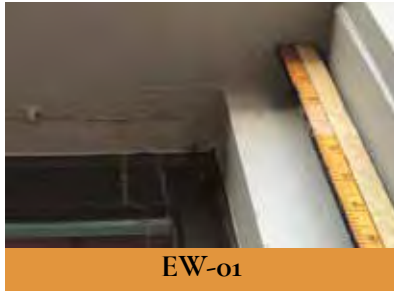
EW-01

The brown stain at the northeast window implies potential rusting of the lintel by water intrusion in the wall.

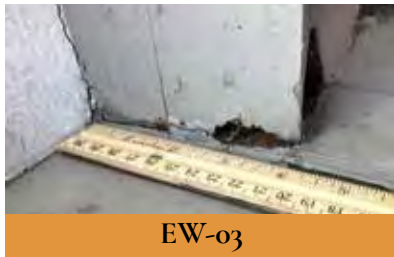
EW-03

Cracks are present where the side jamb, sill, sub sill, and wall meet. The lower jamb has wood rot from moisture.

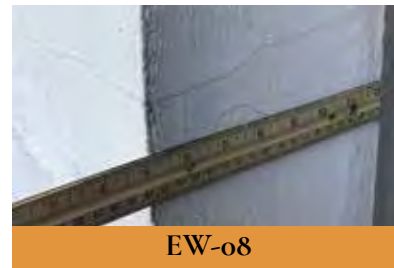
EW-08

**South Door.**

Hairline crack wraps around the south side jamb.

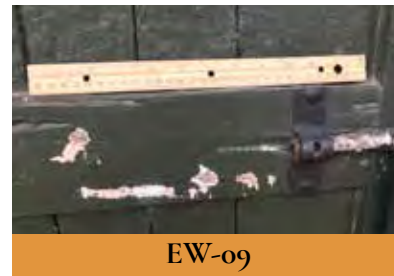
EW-09

**South Door.**

Peeling paint is present on the lock rail.

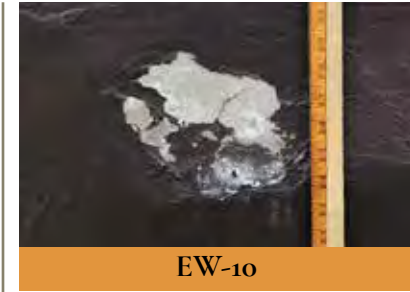
EW-10

**Zocalo.**

Peeling paint is on the zocalo (bottom stripe) to the right of the south window.

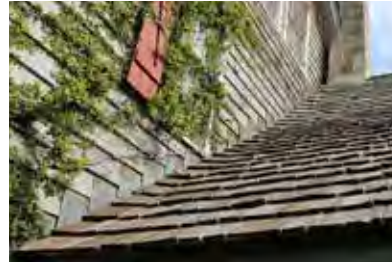
WR-01

View of the copper flashing with petina, where the roof gable meets Rodriguez-Avero-Sanchez House's southern wall.

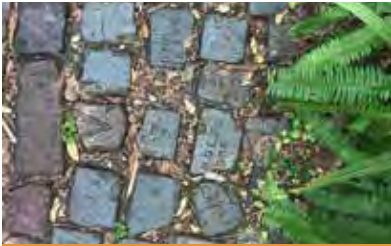
**LP-01**

The uneven pavement with brick fragments appears to be the original design. Minor rounding erosion of the bricks is visible throughout the pavement.

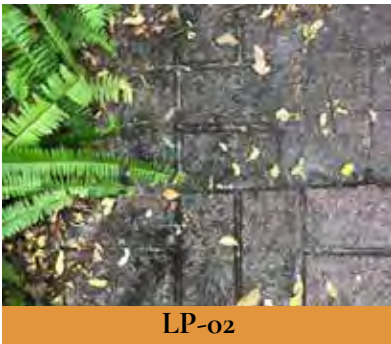
**LP-02**

The concrete-block pavement is near the former south fence (removed in 2018). Soiling is all over the pavement and more visible around the plants.

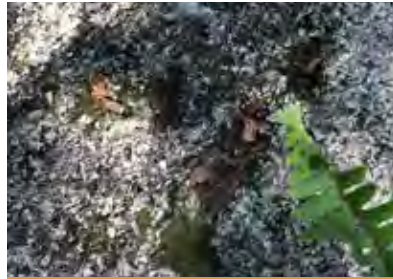
**LP-03**

Erosion occurs on the coquina stones edging the garden beds. Biological growth, such as lichen and moss, is present on the rock surfaces.

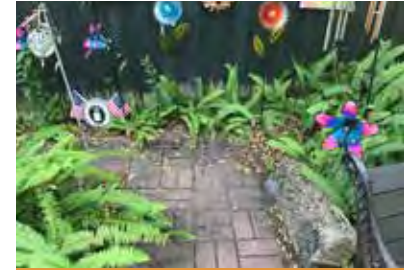
**LS-03**

The wood fence at the south was removed in 2018 as part of the renovation.

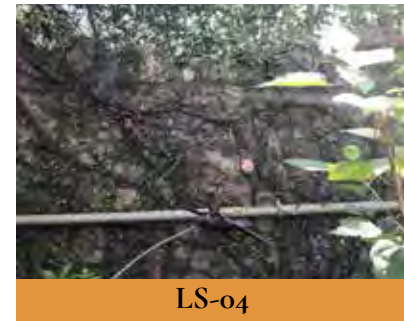
**LS-04**

Biological growth exists throughout the coquina wall (built in 1948) that encloses the backyard.
